#### **TECHNICAL REPORT**

#### BAKER BRIDGE (TH-1) SAFETY AND FUNCTIONAL ASSESSMENT STUDY RIPTON, VERMONT

October 4, 2013

MMI #3928-04-4

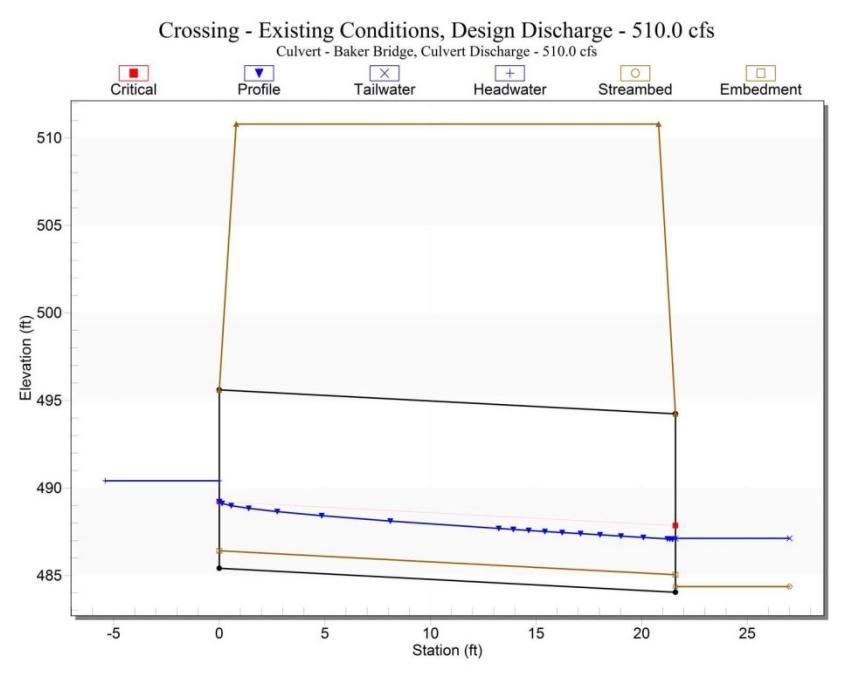
FIGURE 3.2: Hydraulic Drop Through Bridge Structure – Existing Conditions

The results of the existing hydraulic analysis (Appendix D) indicate that the peak flood water surface elevation drops approximately 3.1 feet through the structure during the 25-year storm event (Figure 3.2). Approximately half of the bridge height is filled during the 25-year flood with 5.2 feet of freeboard at the upstream face of the bridge. Exit velocities are estimated to be 13.3 feet per second during a 25-year storm event. During the 100-year storm, the estimated freeboard is 4.0 feet. The hydraulic drop through the bridge increases to approximately 3.8 feet, and the exit velocity increases to approximately 14.8 feet per second.

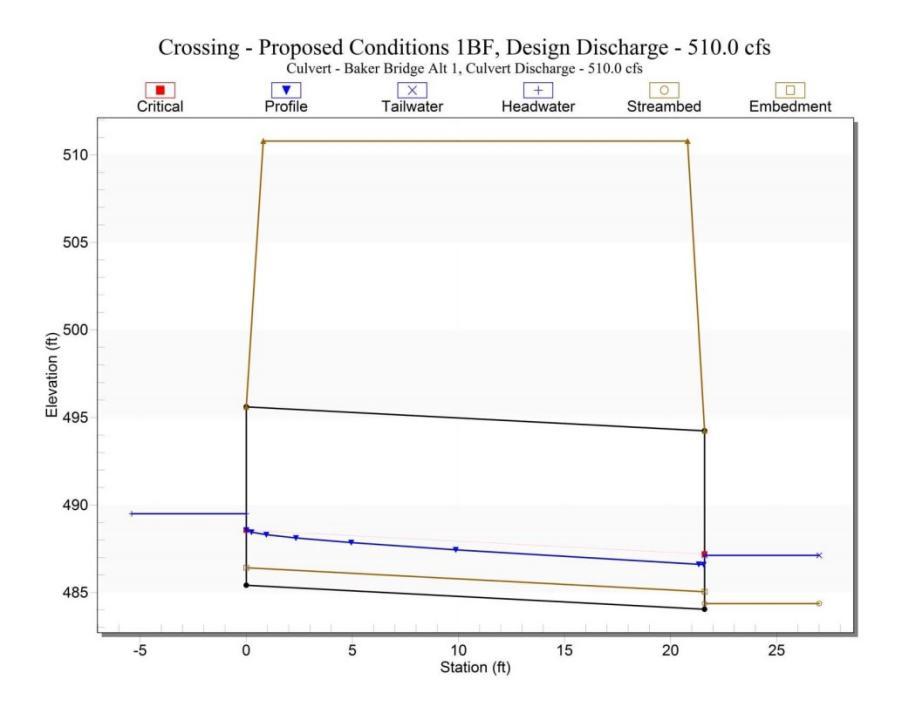
FIGURE 3.3: Hydraulic Drop Through Bridge Structure – Alternative 1

The results of the alternative hydraulic analysis indicate that the hydraulic drop through the bridge structure would decrease from 3.1 feet under existing conditions to 2.4 feet during the 25-year storm event with a 1x bankfull width structure (Figure 3.3). The increase in bridge width would increase freeboard to 6.1 feet and reduce exit velocities to 11.7 feet per second (Table 3.7). The results indicate similar improvements during the 100-year storm event.

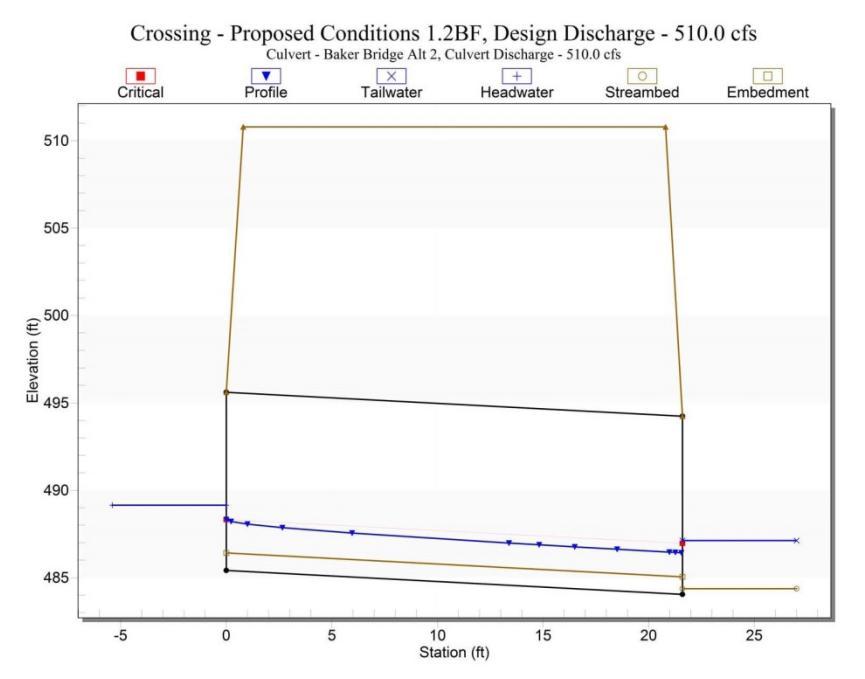
FIGURE 3.4: Hydraulic Drop Through Bridge Structure – Alternative 2

The results of the alternative hydraulic analysis indicate that the hydraulic drop through the bridge structure would decrease further from existing conditions to approximately 2.0 feet during a 25-year storm event and approximately 2.2 feet during the 100-year storm event for the 1.2x bankfull width structure (Figure 3.4). Similarly, the exit velocity would also decrease during both the 25-year and 100-year storm events while additional freeboard would be provided (Table 3.8). Results of the hydraulic analysis exploring the conceptual alternatives are provided in Appendix D of this report.
