| STRUCTURE INSPE | CTION, INVENTORY and APPRAISAL SHEET |
| Vermont Agency of Transportation | on ~ Structures Section ~ Bridge Management and Inspection Unit |
| Inspection Report for : LINCOLN | Bridge No.: 00018 District: 5 |

Team Lead: Justin White, Inspection Date: July 27, 2021

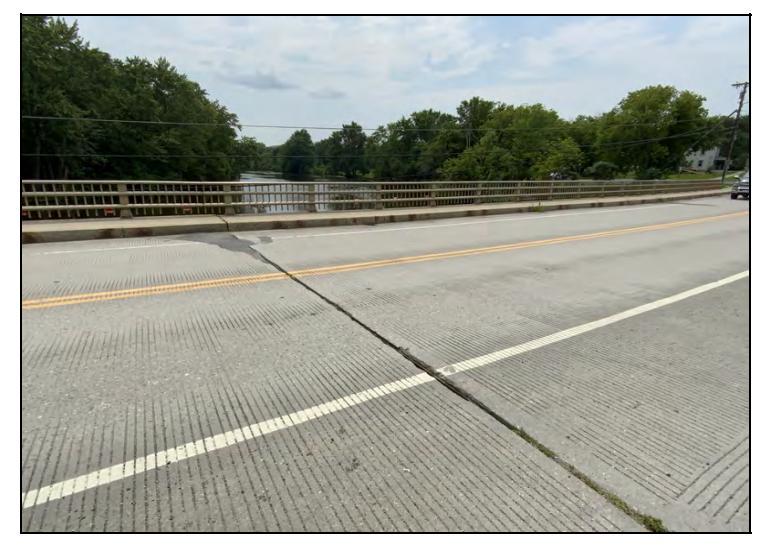
Wearing surface

Comment: Scattered fine transverse shrinkage cracks throughout. The areas surrounding the upstream ends of the joints have large patched areas with depressions and surrounding cracks.

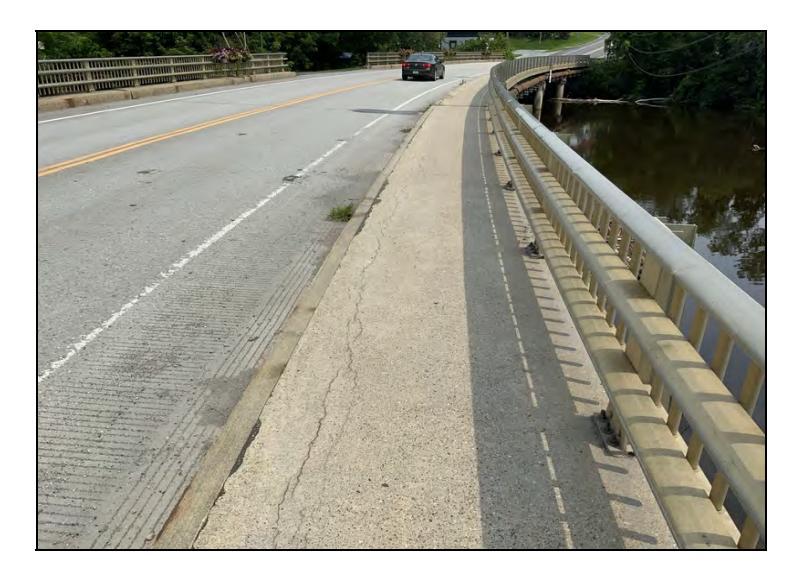
Sidewalk

Comment: Lineal cracking along the curb edge throughout with areas of minor separation and minor rust staining. Areas along the curb joint have scattered small spalls and pop outs. Areas surrounding the joint ends at the curb and fascia have delams and some small full depth holes.

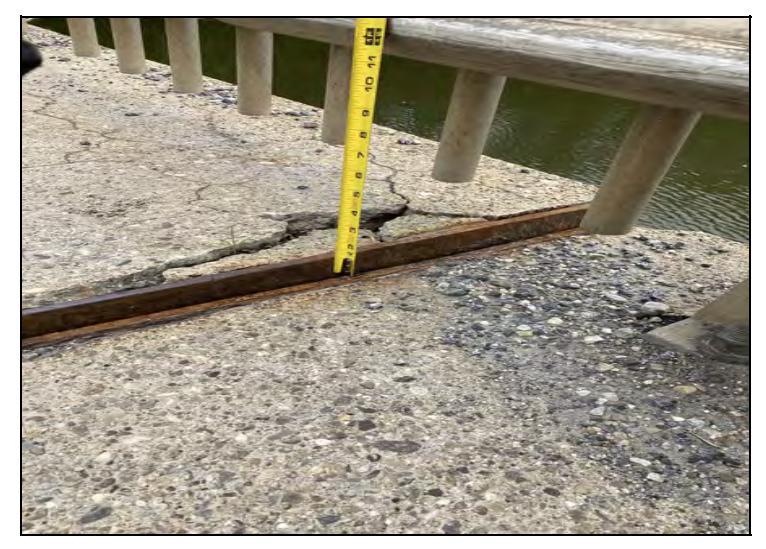
Pier 2 joint

Joint Trough Comment: If troughs remain they have mostly collapsed due to extensive debris build up caused by the open joints.

The failed membranes of the compression joints over the piers has allowed for debris build up and continued saturation of the surrounding elements for many years and has lead to failures in the caps of piers 2, 3, and 4. A joint replacement or elimination project should be considered.

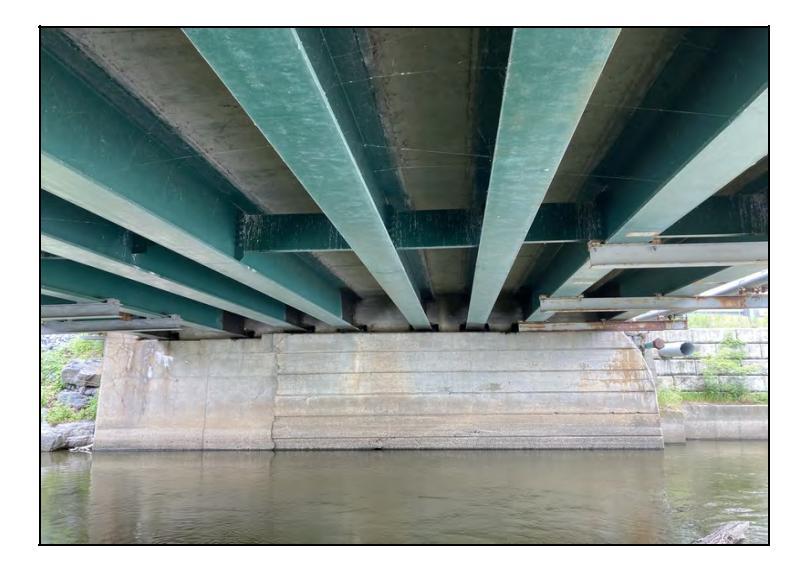
Abutment 1

Comment: Map cracking in the ends with light staining and some minor saturation.

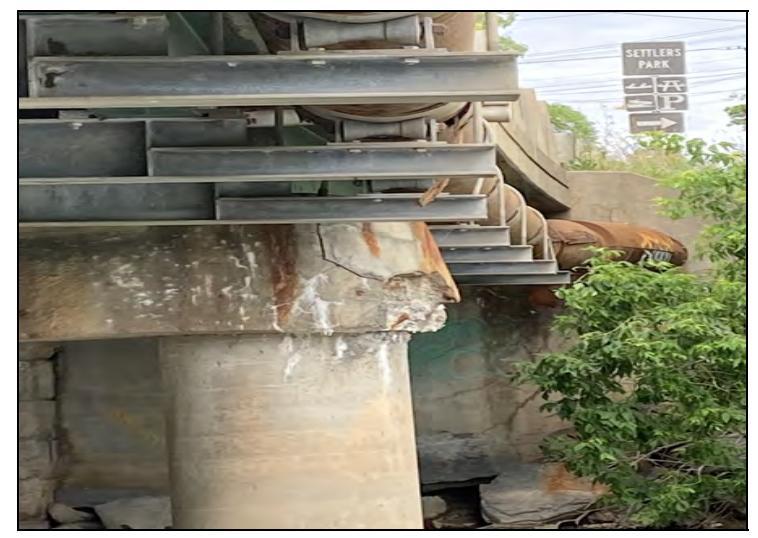
Pier 4 upstream end

Comment: Areas of voided spalling scattered throughout with heavy scaling and exposed reinforcing. Some interior areas have been patched in the past but the upstream ends of piers 2, 3, and 4 remain in poor condition with some undermined bearings. The upstream end of the pier 2 cap is cracked/segmented through causing the undermining of the upstream fascia beam bearing of span 2. This undermining has caused some minor settlement which is visible in the sidewalk joint above with a 1"+/- drop in the span 2 side of the joint.

Continued spalling in the upstream ends of the piers has lead to areas of undermining in the fascia beam bearings and exposed reinforcing. Pier 2 is the most significant with a wide segmented crack in the end that has undermined and caused the settlement of the span 2 fascia beam bearing. Settlement is visible in the sidewalk joint above with 1"+/- drop in the span 2 side of the joint. There are also other less significant spalls scattered along the pier caps but if allowed to continue they will undermine other bearing areas. A project to remove and repair all deteriorated concrete along the pier caps should be considered.

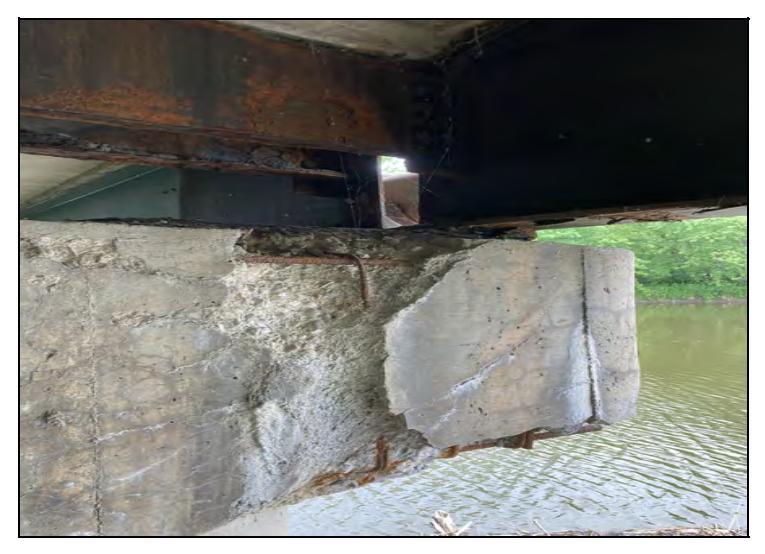
Pier 2 upstream cap end

Comment: Fine map cracks throughout with light staining, scattered small areas of rust staining, and some small spalls. Pier 2 has extensive spalling along the arch area exposing the outer layer of reinforcing with rotted out stirrups.
