AHEAD OF THE STORM EXISTING CONDITIONS SUMMARY

Location: Hollow Brook, Sugarhouse Lane, Starksboro, Vermont

MMI #:	3452-36
DATE:	1/28/2021
RE:	Alternatives Analysis – Hollow Brook Refugia Design
FROM:	Jessica Louisos, PE, Roy Schiff, Phd, PE, & Claire Nauman, SLR
TO:	Lewis Creek Association

Hollow Brook Refugia Design Alternatives Analysis Matrix Starksboro, Vermont January 28, 2021

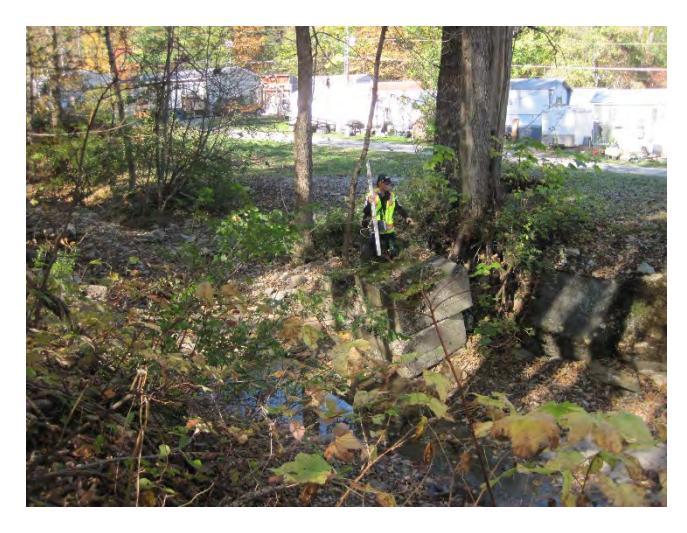
Figure 13: When flow backs up at the old abutment constriction, the water flows out onto nearby Elm Lane, damaging homes, and carrying sediment (October 9, 2020).

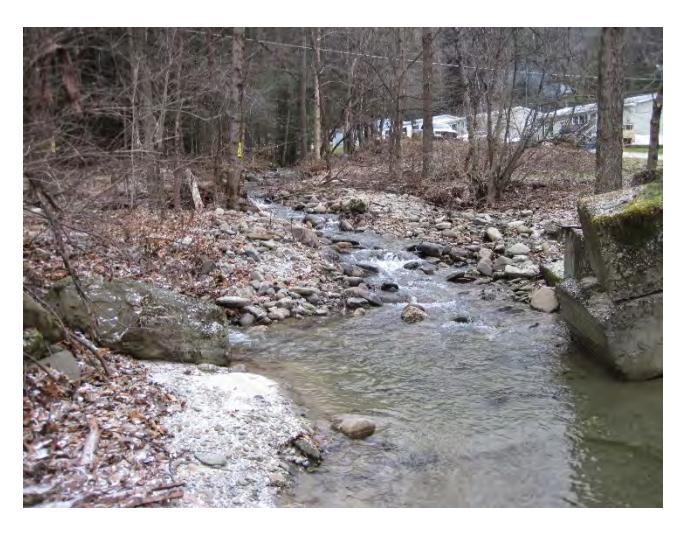
Figure 15: View of old bridge abutments looking upstream. There is a steep riffle and sediment deposit filling the river channel and contributing to flows leaving the channel (December 12, 2020).

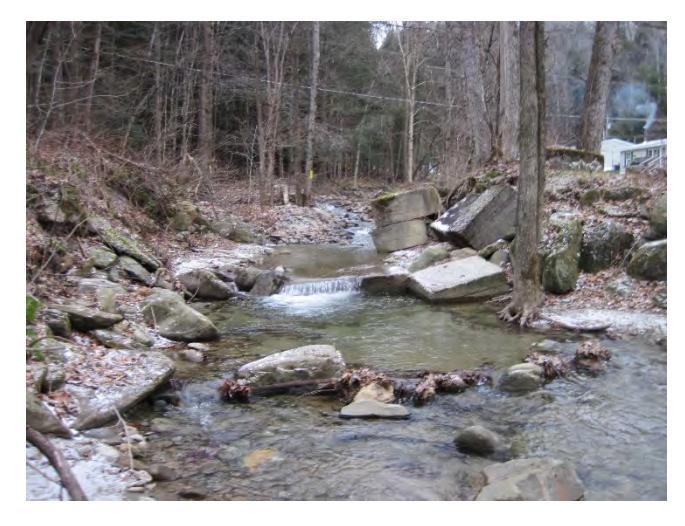
Figure 14: A concrete sill crosses the river at an abandoned crossing. Abutments constrict channel to 12.5' wide. View of old bridge abutments looking upstream (December 6, 2020).

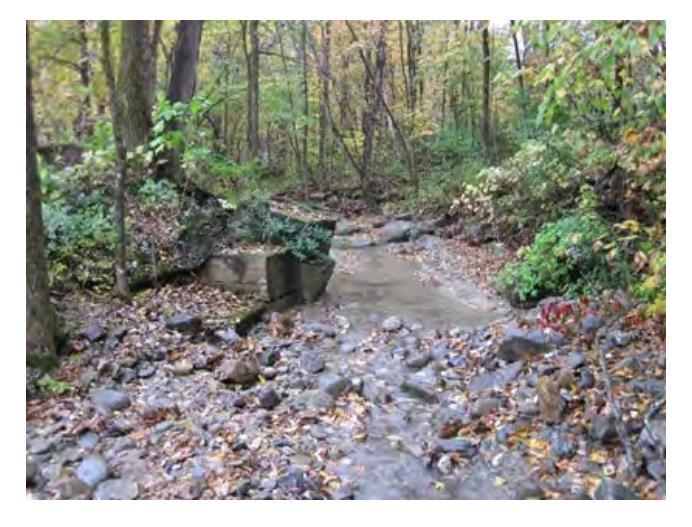
Figure 16: View of old bridge abutments looking downstream (October 2, 2020).

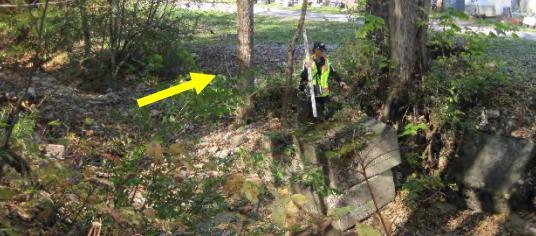
Abandoned bridge abutments near Elm Lane are constricting the river and causing floodwaters to leave the channel and flow into the neighborhood. The former road bed is elevated with fill across the narrow valley, filling the floodplain. The remaining concrete constricts the river to only 12.5 feet, narrower than the 20 foot bankfull width (63% of the bankfull channel width). The concrete sill across the river bed prevents fish passage during low flows (Photo 1). Residents report that flood flows have left the channel immediately upstream of the constriction and flowed into the neighborhood depositing sediment, washing out the road, and damaging homes (Photo 2). A large steep sediment deposit is located immediately upstream of the

Photo 2: Yellow arrow shows where water has exited the channel upstream of old bridge abutments and concrete

blocks (October 10, 2020).

Remove old bridge abutments, concrete blocks, and fill from the road embankment. This will open the channel to match bankfull width upstream and restore the potential for floodplain flow. Use deposited channel materials upstream to create uniform channel slope through former bridge location. Remove excess sediment from large upstream bar.

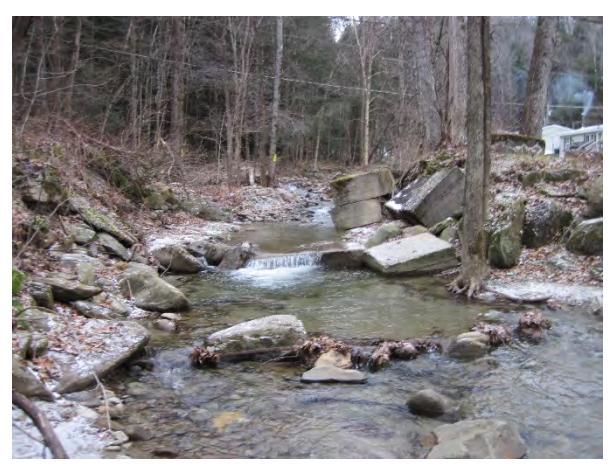
Photo 1: View of old bridge abutments and concrete blocks from downstream (December 6, 2020).
