То:	Town of Lincoln, Vermont	From:	Brian Cote, PE, CFM
			Osman Pekin
			Elizabeth Richards
Company:		SLR International Corporation	
cc:	Addison County Regional Planning	Date:	September 18, 2023
	Commission	Project No.	146.13928.00008
RE: Rive	r Road Stabilization

RIVER ROAD STABILIZATION PROJECT TOWN OF LINCOLN, VERMONT

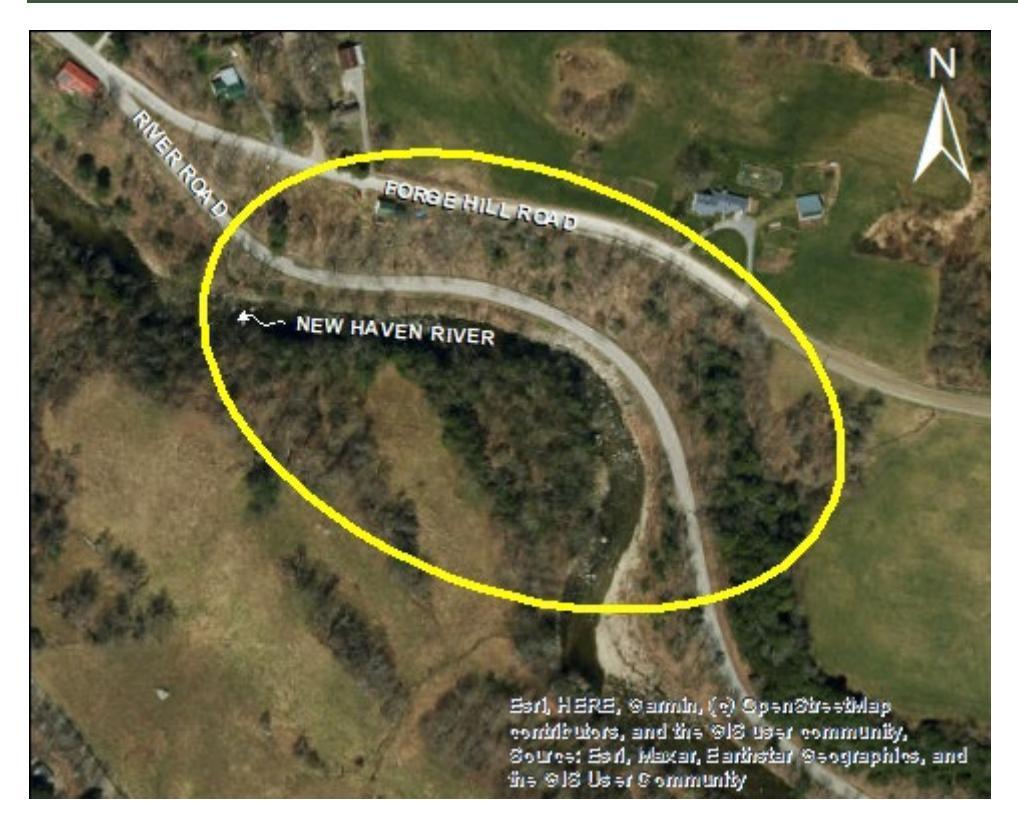
Figure A: River Road Project Area

The New Haven River travels through a narrow valley and is located directly adjacent to the embankment of River Road at the project site (Figure 1). The River Road embankment has historically been armored with large riprap to resist erosion that has occurred within the project reach. Maintaining the riprap slope has been challenging given the direct flow impingement, the steepness and height of the embankment, and dynamic nature of the New Haven River. There is also concern with the stability of the tall, steep slope on the north side of River Road may also be actively destabilizing this section of the roadway.

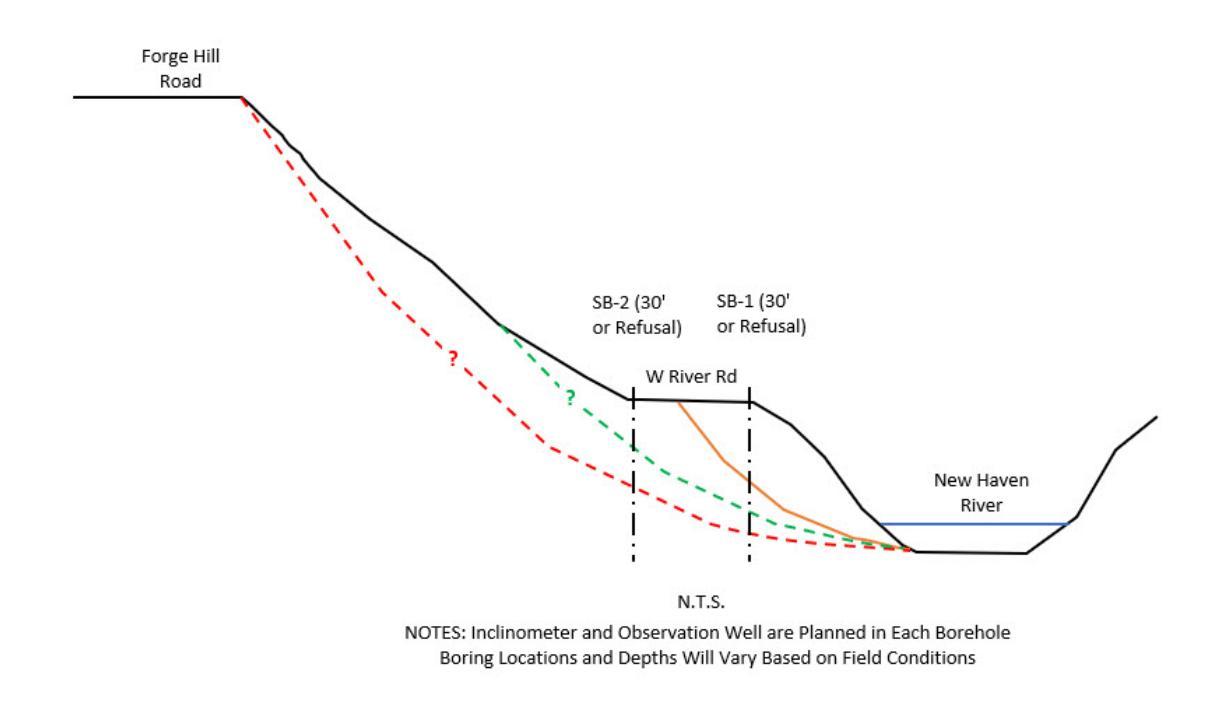
Figure C: Schematic of Various Slope Failure Scenarios (Source: SLR)

Evidence was observed in the field that indicates that the lower portion of the slope between River Road and New Haven River is experiencing slope movement. This is likely triggered by scouring along the northeasterly bank of the river within its southwest-facing bend. It is less clear if potential slope instability extends further uphill, between River Road and Forge Hill Road. If there is any potential instability in the uphill portion of the slope, it is not clear if it has a shallow slide risk or a deep-seated slide (Figure C). The orange line depicts a slope toe failure, which is reasonably substantiated by observations in the field. The green line (i.e. – shallow slide) or red (i.e. – deep-seated slide) are unknown scenarios that involve the larger slope.

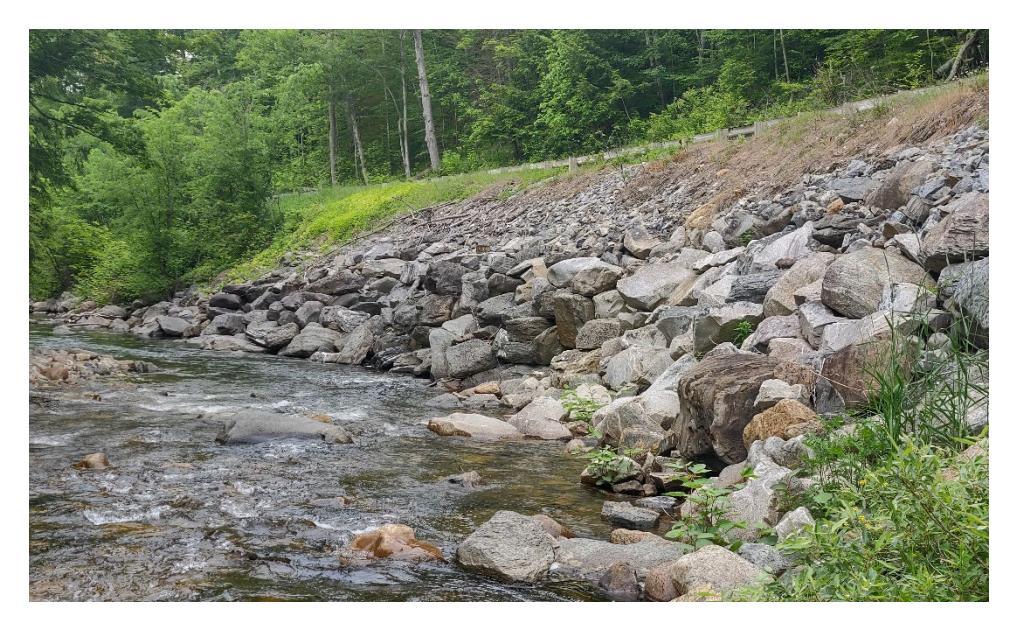
Figure D: Existing Roadway Embankment

The roadway embankment is currently lined with riprap along an approximately 250-foot section of the New Haven River within the project area. River Road is showing signs of settlement and movement (i.e., longitudinal cracking of roadway surface and leaning guardrail). Road drainage is causing localized rill erosion on the south side of the roadway where stormwater runoff leaves the roadway surface and collects before flowing down the steep slope to the river. Additionally, the steep slope between Forge Hill Road and River Road is showing signs of movement and instability that may be applying pressure to the roadway in the project area as well. The New Haven River flows directly adjacent to the roadway embankment. The alignment is causing direct flow impingement on the base of the embankment contributing to the slope instability. To address the instability, a stacked riprap wall with steep armored upper bank has been implemented along this section of River Road within the limited space available between the roadway and river. Vegetation along the roadway embankment that has not been eroded away is limited to grasses and small shrubs within the section that is most vulnerable to erosion risks.

A metal-beam guiderail exists at the edge of the roadway along the length of the embankment within the project area. Sections of the guiderail are leaning towards the river indicating that the slope is unstable and likely moving. There is also cracking along the direction of travel in the road that is visible in the pavement of the roadway surface that also may be an indication of the road embankments instability. There are several small earth berms at the top of the slope just behind the guiderail that concentrate runoff flowing off the roadway surface. The berms may be the result of buildup of winter road sand and eroded sediment.
