# Lewis Creek Flood Mitigation Study

Alex Marcucci, CFM &  
Jessica Louisos, PE

August 1, 2024

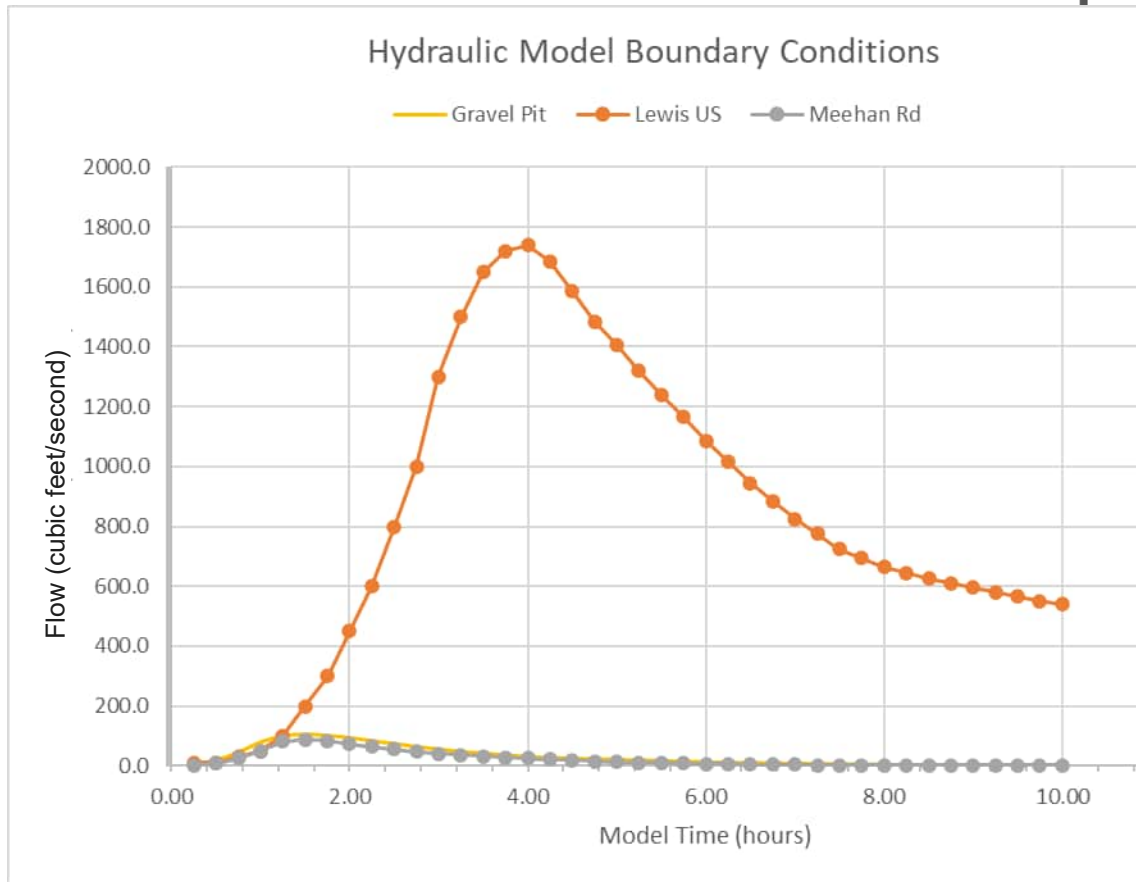
Figure 1: 100-Year Flood Hydrographs

- USGS gage analysis performed
- Flows used in model calculated with regression equation (Jacobs, 2010\*)

Recurrence Interval	Lewis Creek	Meehan Road Tributary	Gravel Pit Tributary
2-year	423	22	26
5-year	682	35	42
10-year	917	47	56
25-year	1,234	63	75
50-year	1,478	75	90
100-year	1,740	88	106
500-year	2,579	130	156

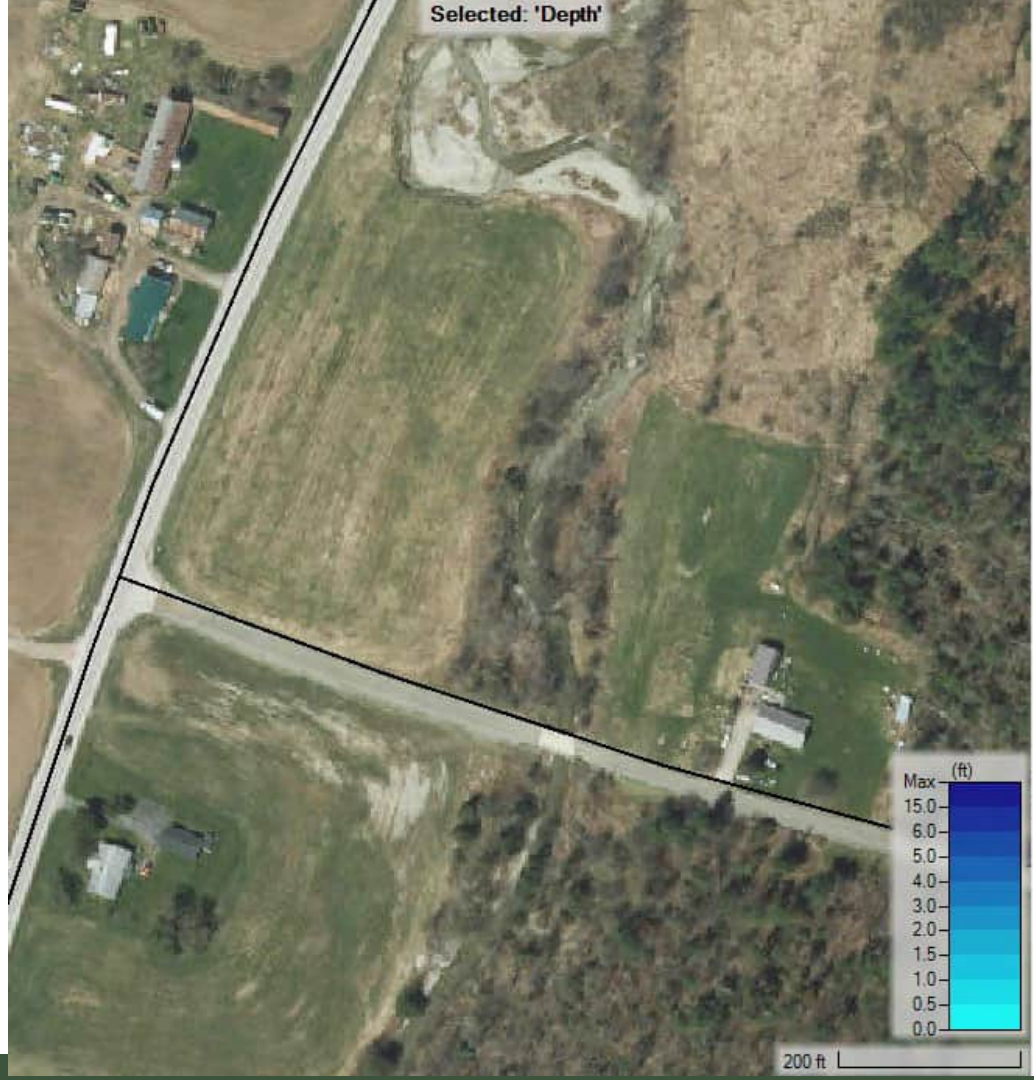
- Lewis Creek flowing north
- Crossing Hillsboro Road in this example view

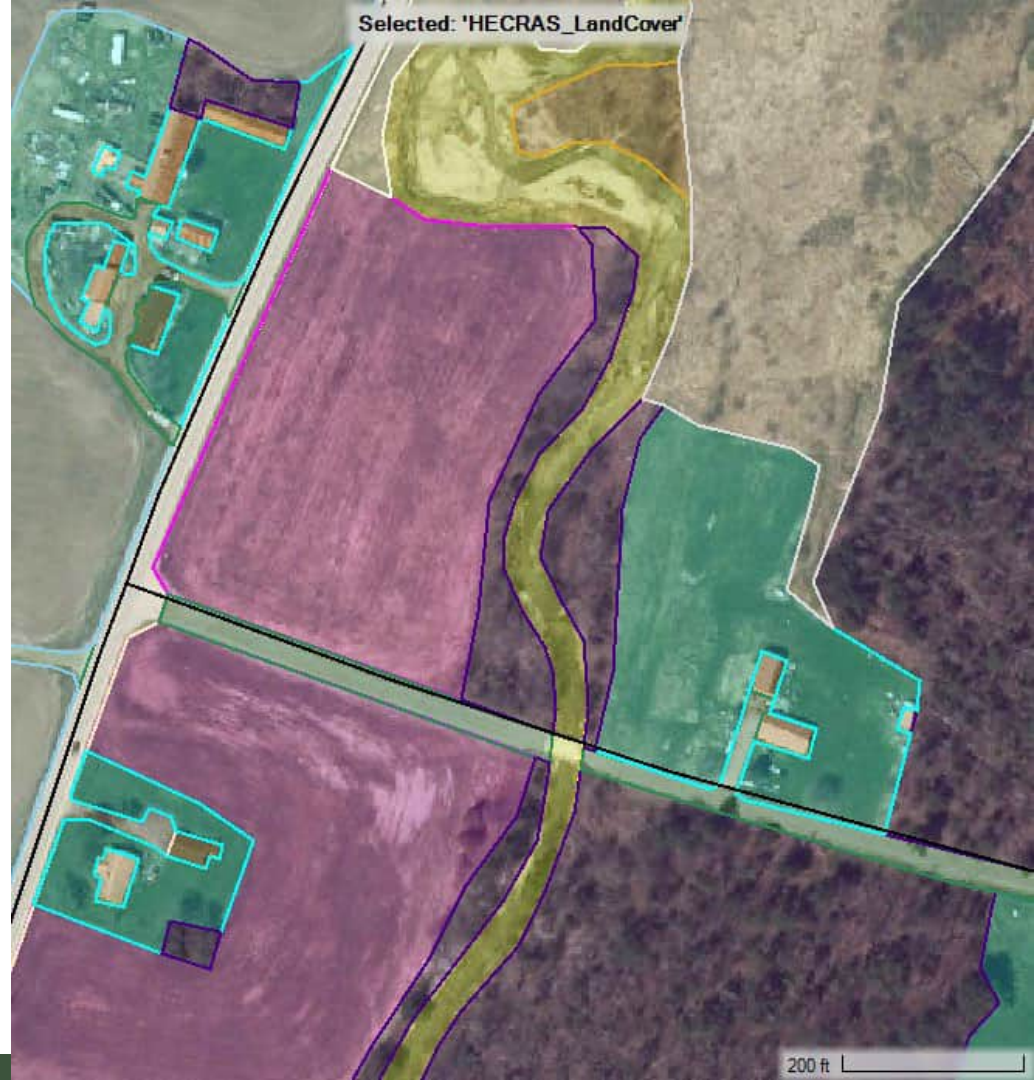
- Landuse entered as roughness values
- Digitized by aerial and checked with field observations

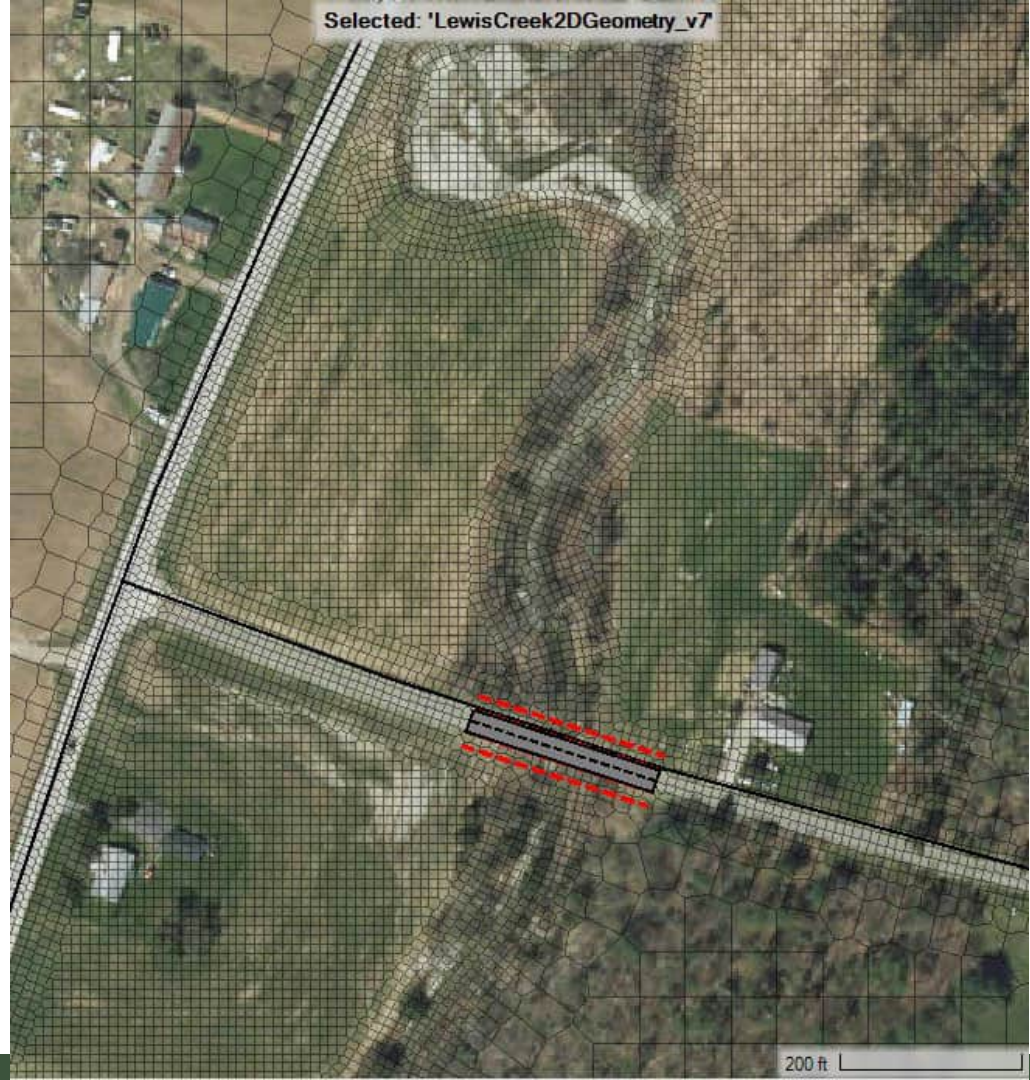
- Model mesh refined to accurately show berms, road edges, channel
- Bridges and culverts inserted using historic plans, collected LiDAR, and high accuracy GPS data

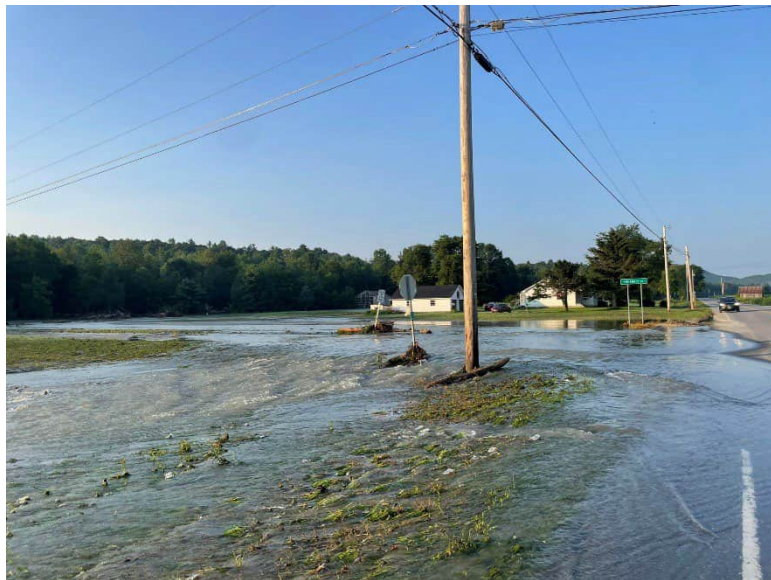
- 100-year dynamic model run
- Depth maximums
- 1.3 feet over Hillsboro Road

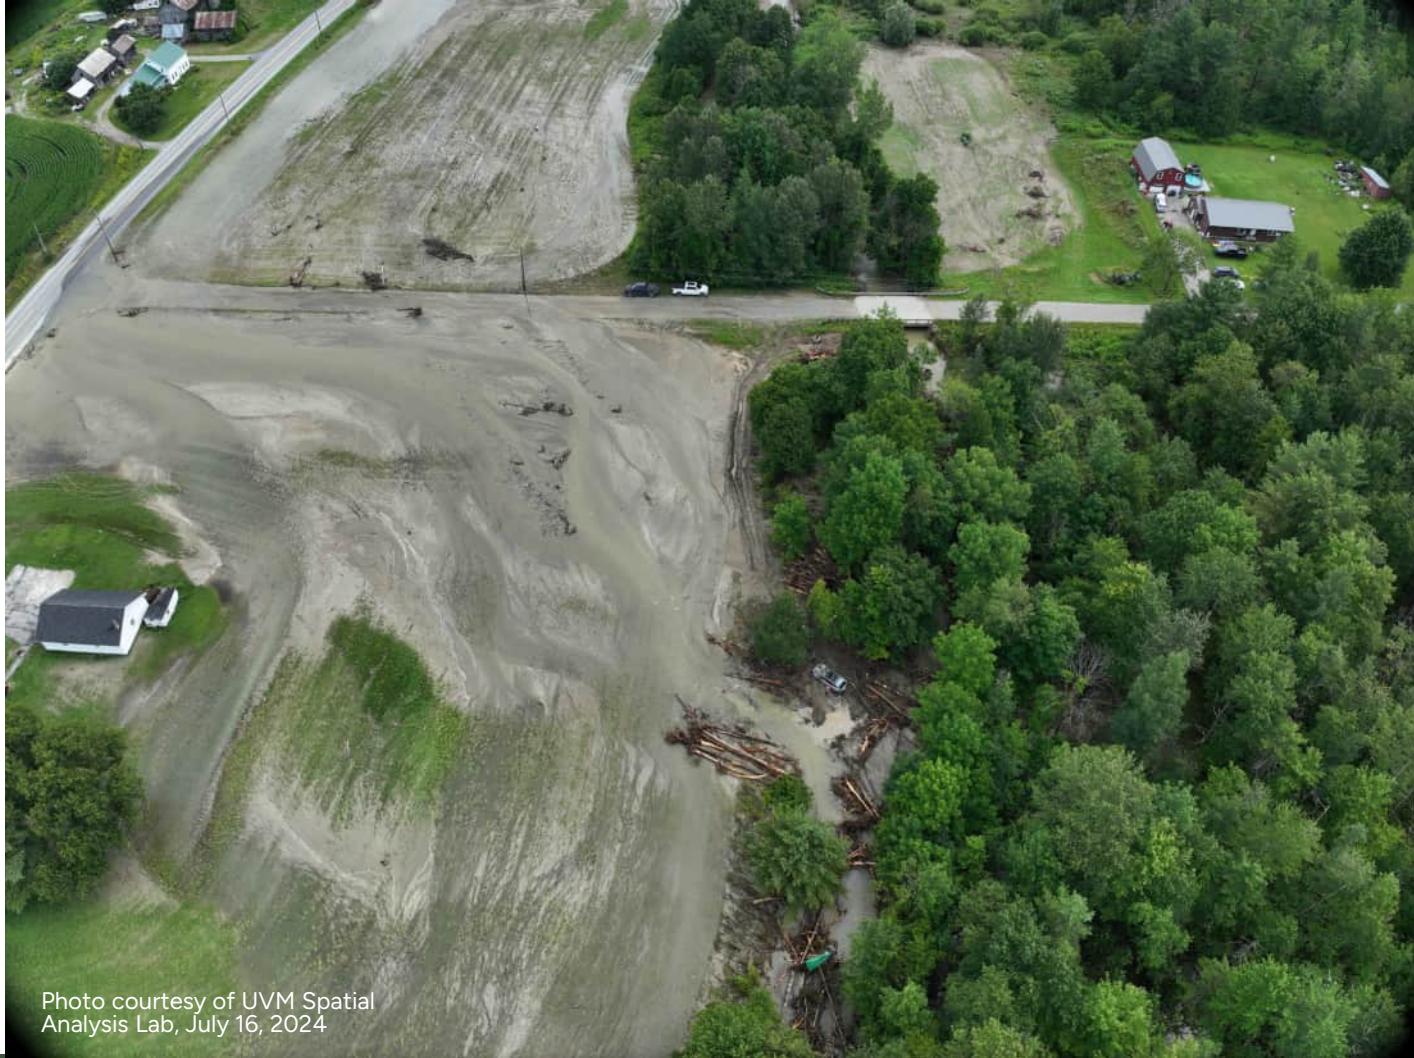
Photo courtesy of UVM Spatial  
Analysis Lab, July 16, 2024

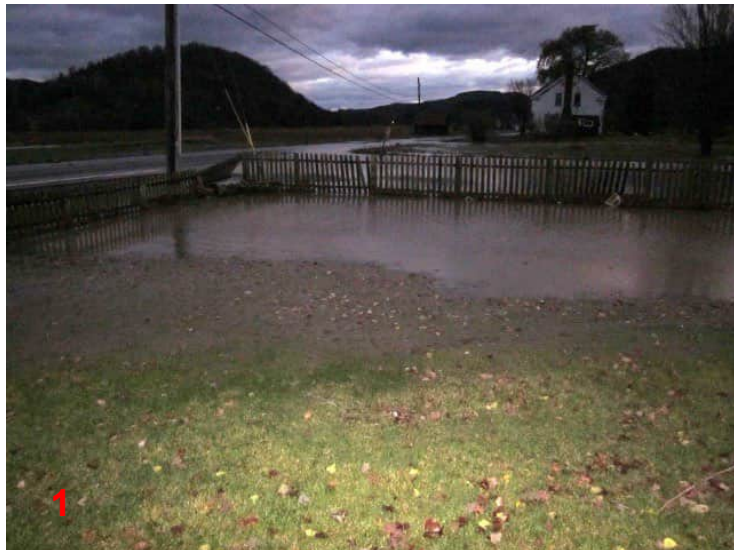
- Halloween 2019 – Along Route 116
- Modeled 100-year Depth =
  - 0.8 ft in around home
  - 0.2 feet on Route 116

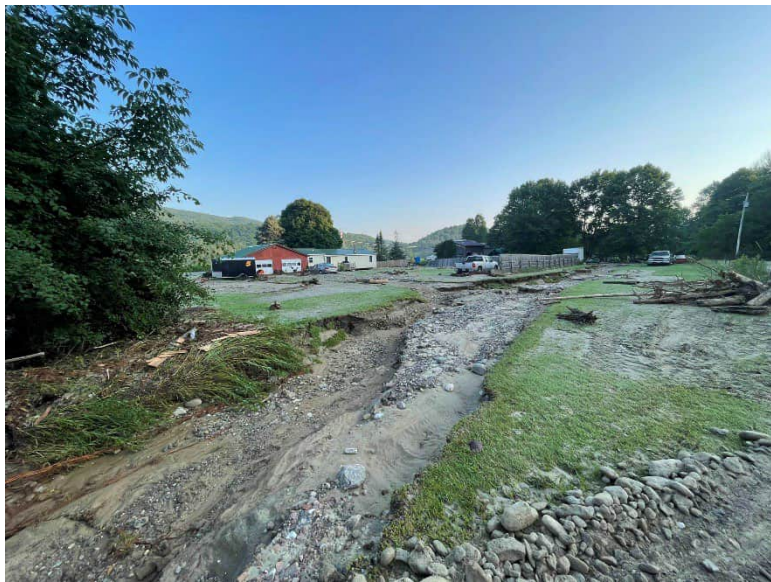
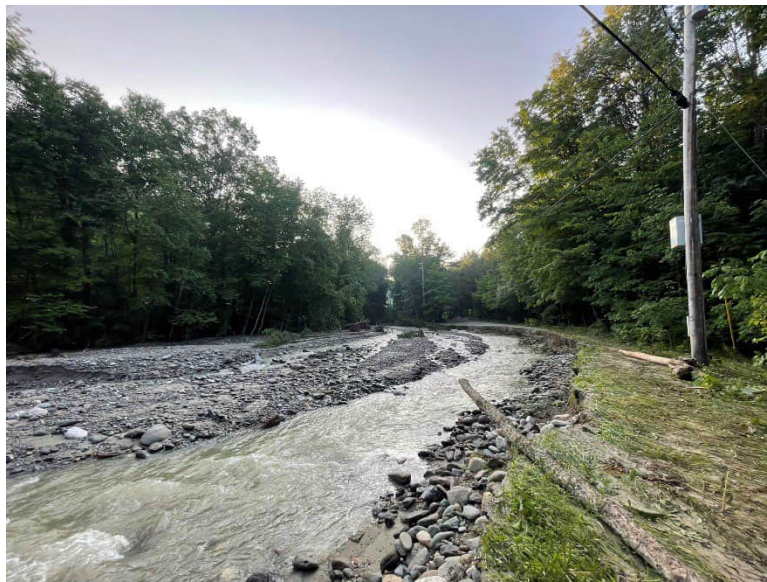
- Flooding at and around many homes
- Shamrock Drive erosion and sediment
- Driveway Bridge washed out
- Ireland Road Damage
- Hillsboro Road covered with water for days and clogged with sediment and debris

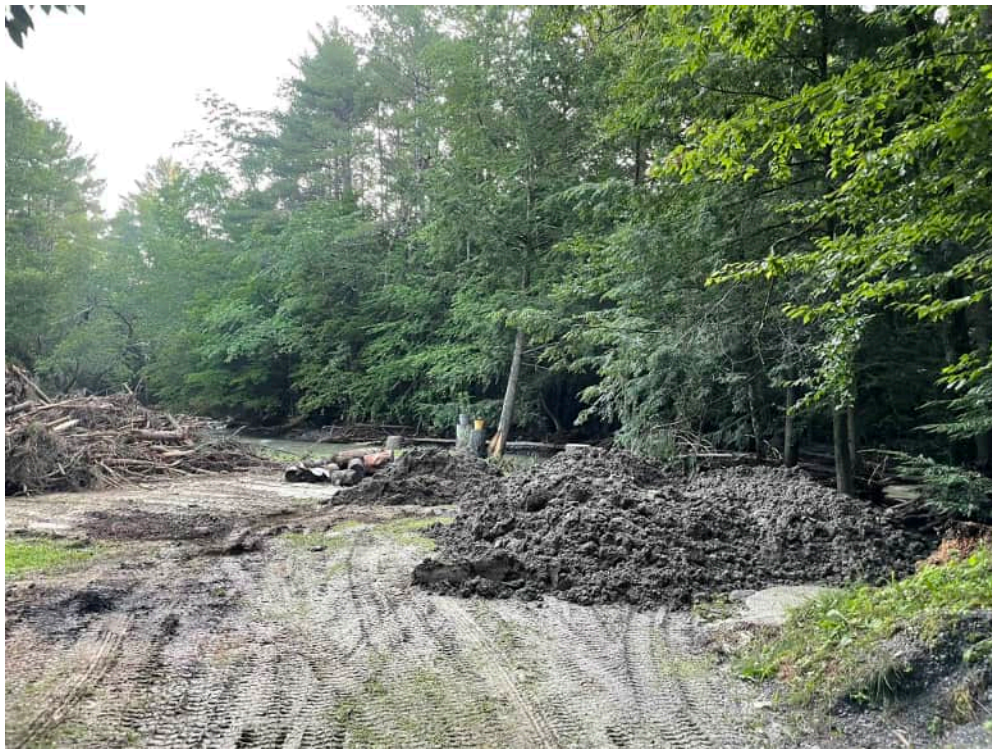
- Alluvial fan where the river changes from steep and narrow to flat and wide
- Natural deposition location
- No model will accurately predict where the next floodpath may be
- Very large sediment input that changes channel configurations and flow directions
- These are extremely risky settings

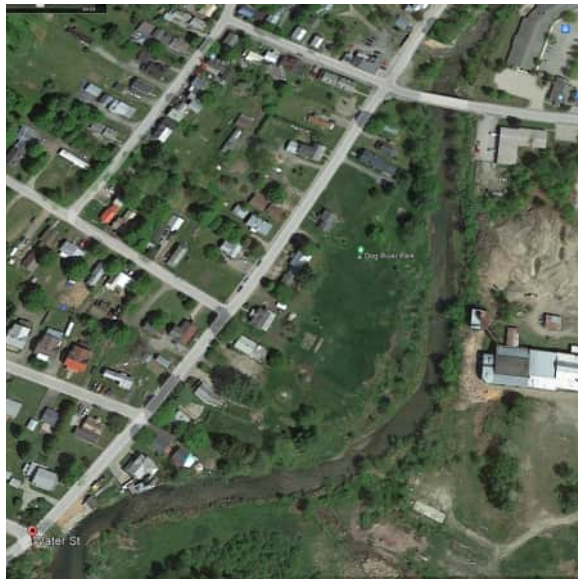
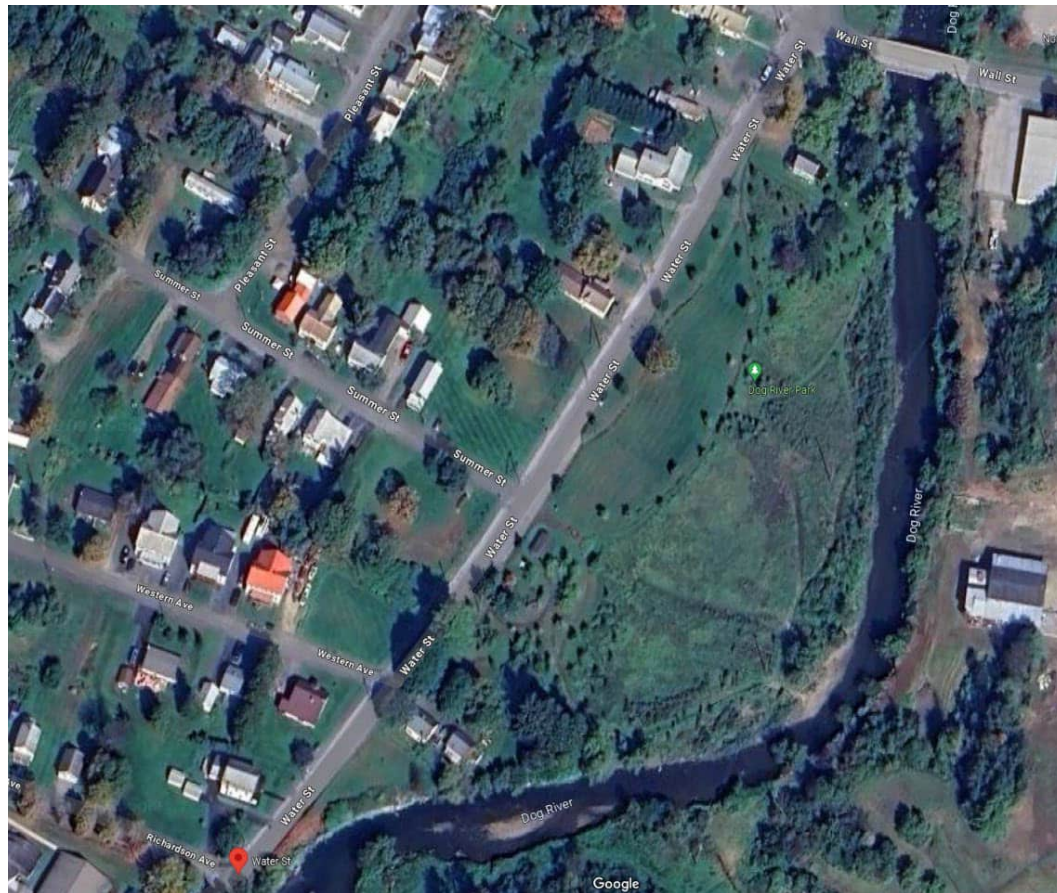
- Remove 7 damaged homes
- Remove 9,000 CY fill in floodplain & lower land average 4 feet over 3 acres
- Remove berm
- Plant restored floodplain with native vegetation

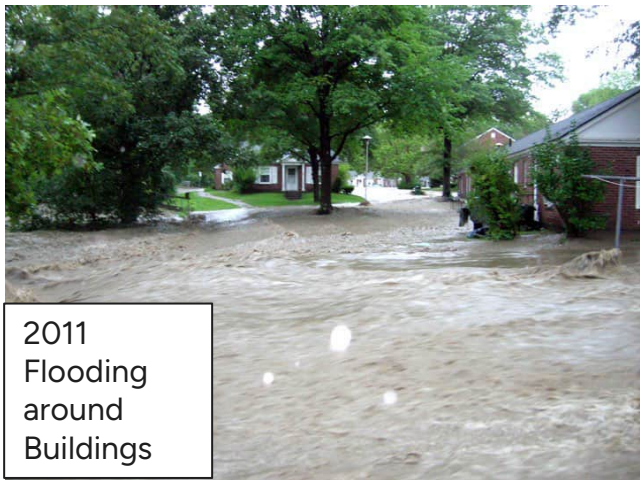
2011  
Flooding  
around  
Buildings

- Remove 11 buildings
- Relocate road
- Relocate sewer main / utilities

- Remove 28,000 CY fill in floodplain & lower land average 5 feet
- Plant restored 4.4-acre floodplain with native vegetation

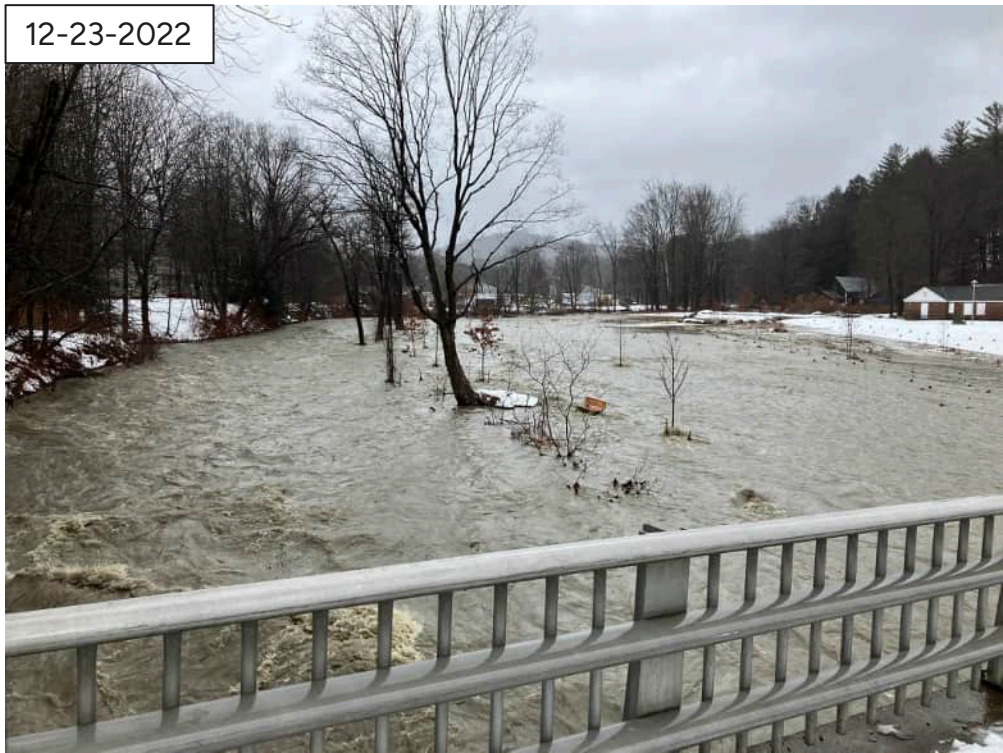
12-23-2022

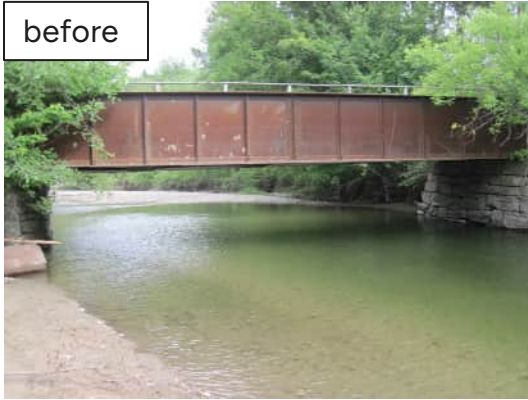
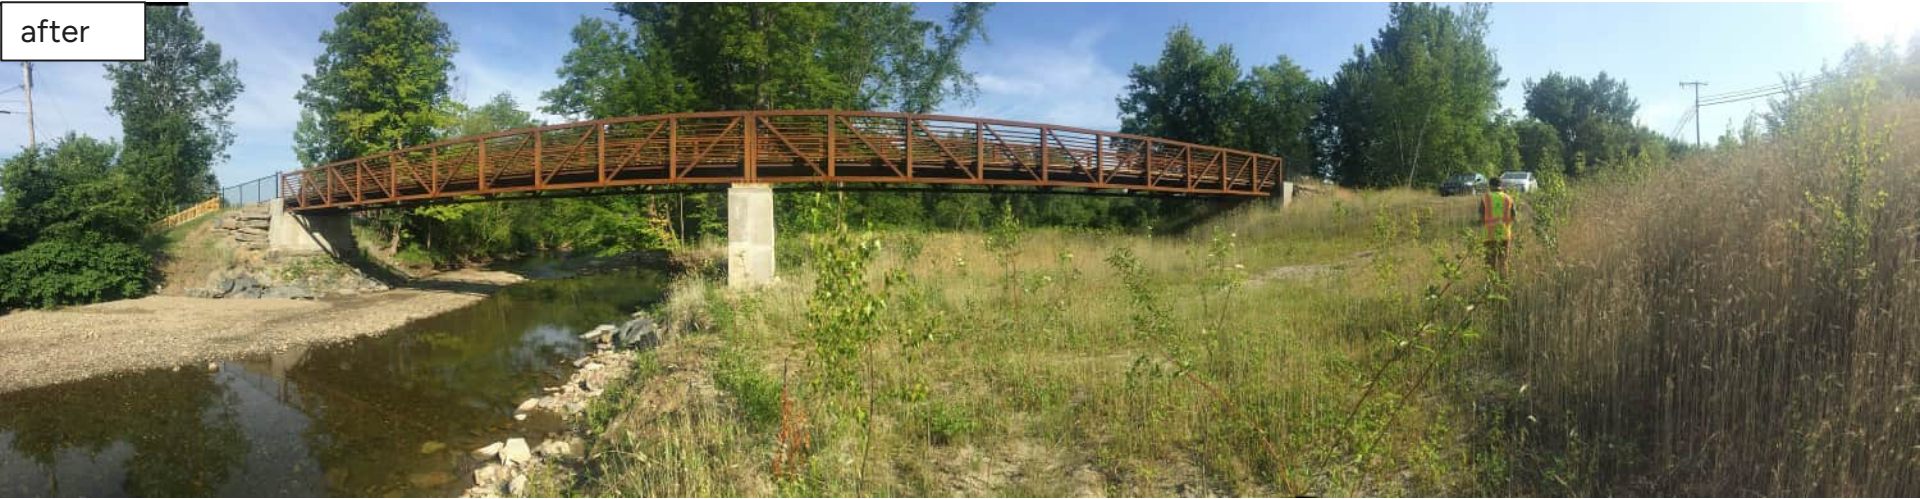
- An undersized bridge and unused abutments were removed
- Larger bridge installed
- Opened up floodplain under bridge

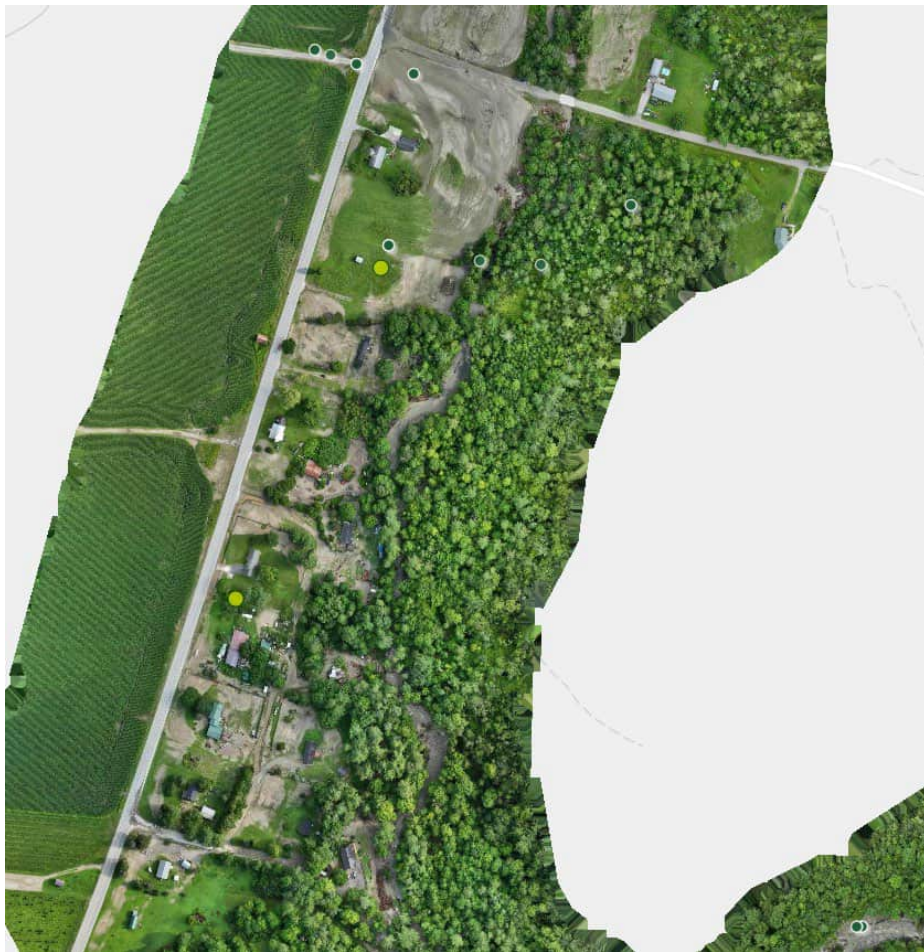
- Removing people and infrastructure from harm's way
- Pair with floodplain restoration for additional flood mitigation benefit

Figure courtesy of UVM Spatial Analysis Lab, imagery collected on July 16, 2024

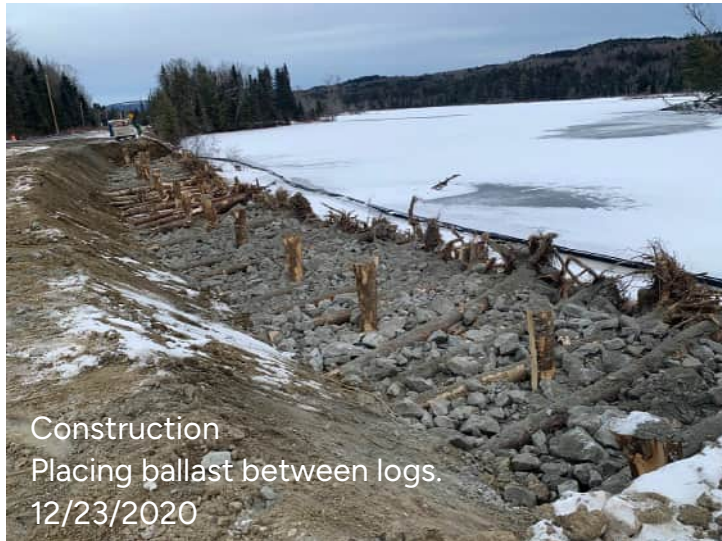
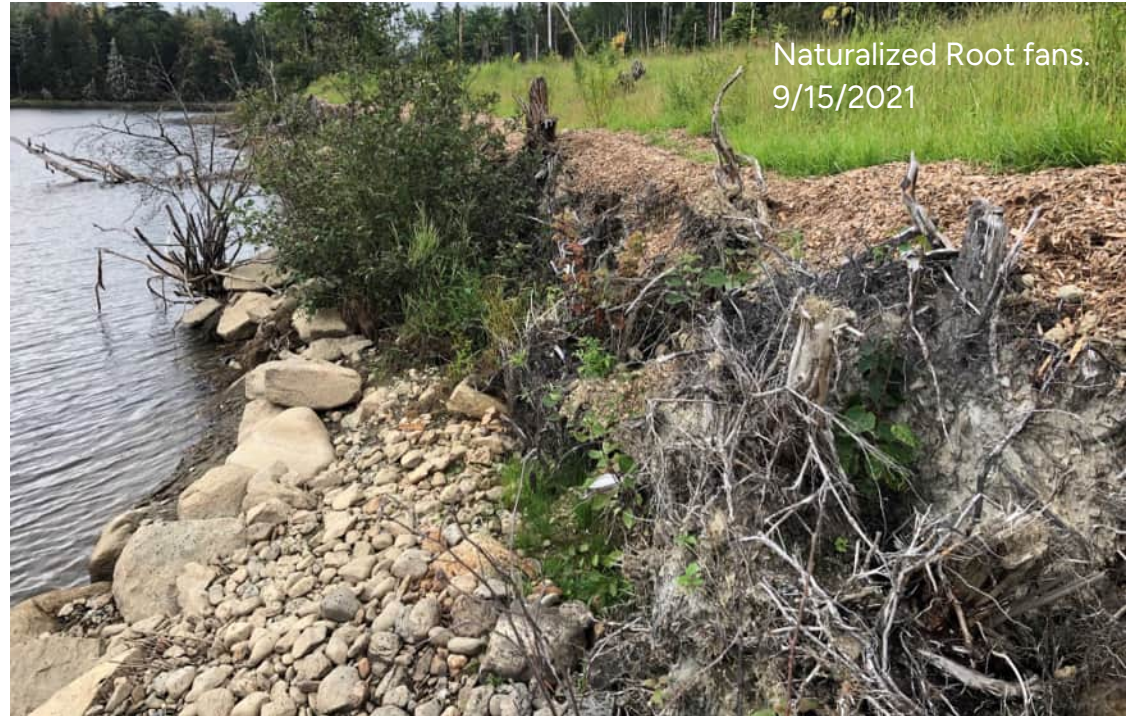
- Proactive road stabilization
- Could include habitat improvement
