#### **TECHNICAL REPORT**

#### BAKER BRIDGE (TH-1) SAFETY AND FUNCTIONAL ASSESSMENT STUDY RIPTON, VERMONT

October 4, 2013

MMI #3928-04-4

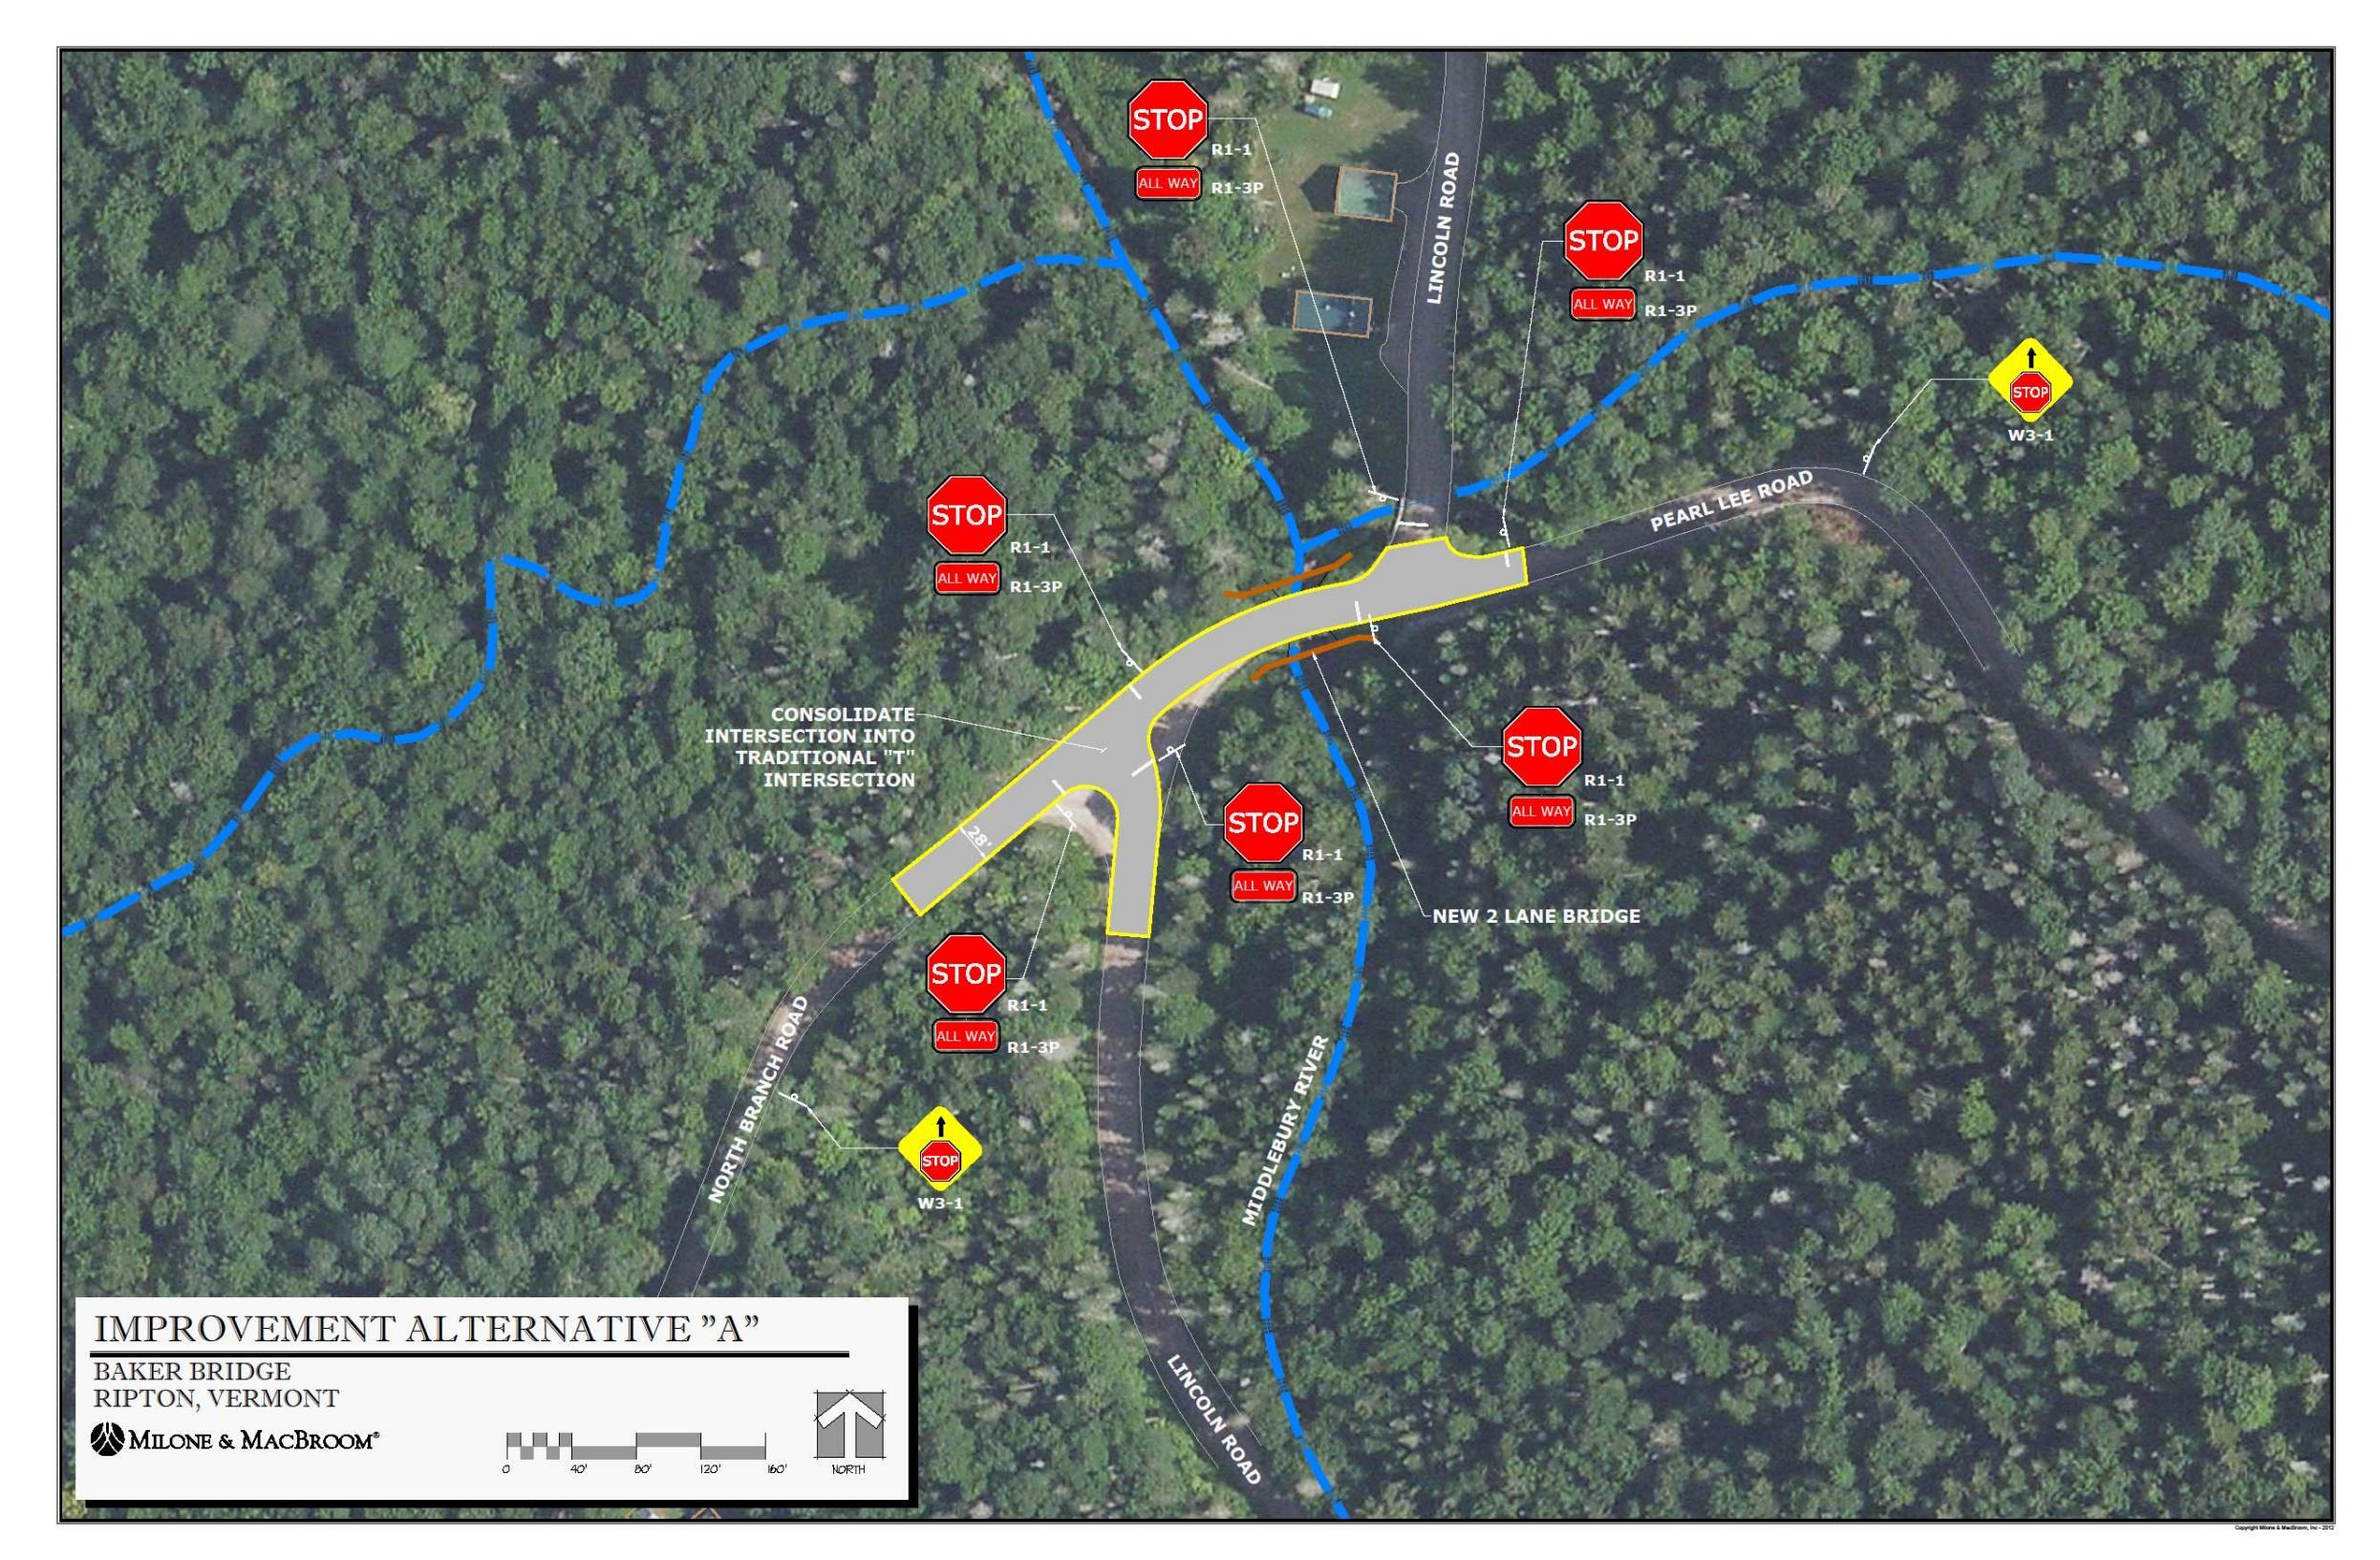
Figure 4.1- Improvement Alternative A

*Improvement Alternative A* would maintain the existing intersection offset configuration; however, the channelized lanes on the Lincoln Road northbound approach will be consolidated into a more traditional "T" intersection with North Branch Road. The existing bridge would be widened to accommodate two lanes of traffic, and the roadway across the bridge would be widened to 28 feet (12-foot lanes with two-foot shoulders). "All Way Stop" sign control is proposed at both intersections to calm traffic and improve safety. It should be noted that this alternative proposes two "All Way Stop" controlled intersections, one on either side of the bridge. In addition, "Stop Ahead" signs would be installed on North Branch Road and Pearl Lee Road in advance of the offset intersection. Given that the majority of this alternative occurs within the existing roadway alignment, potential impacts to natural resources will be limited. Figure 4.1 presents a layout of *Improvement Alternative A*.

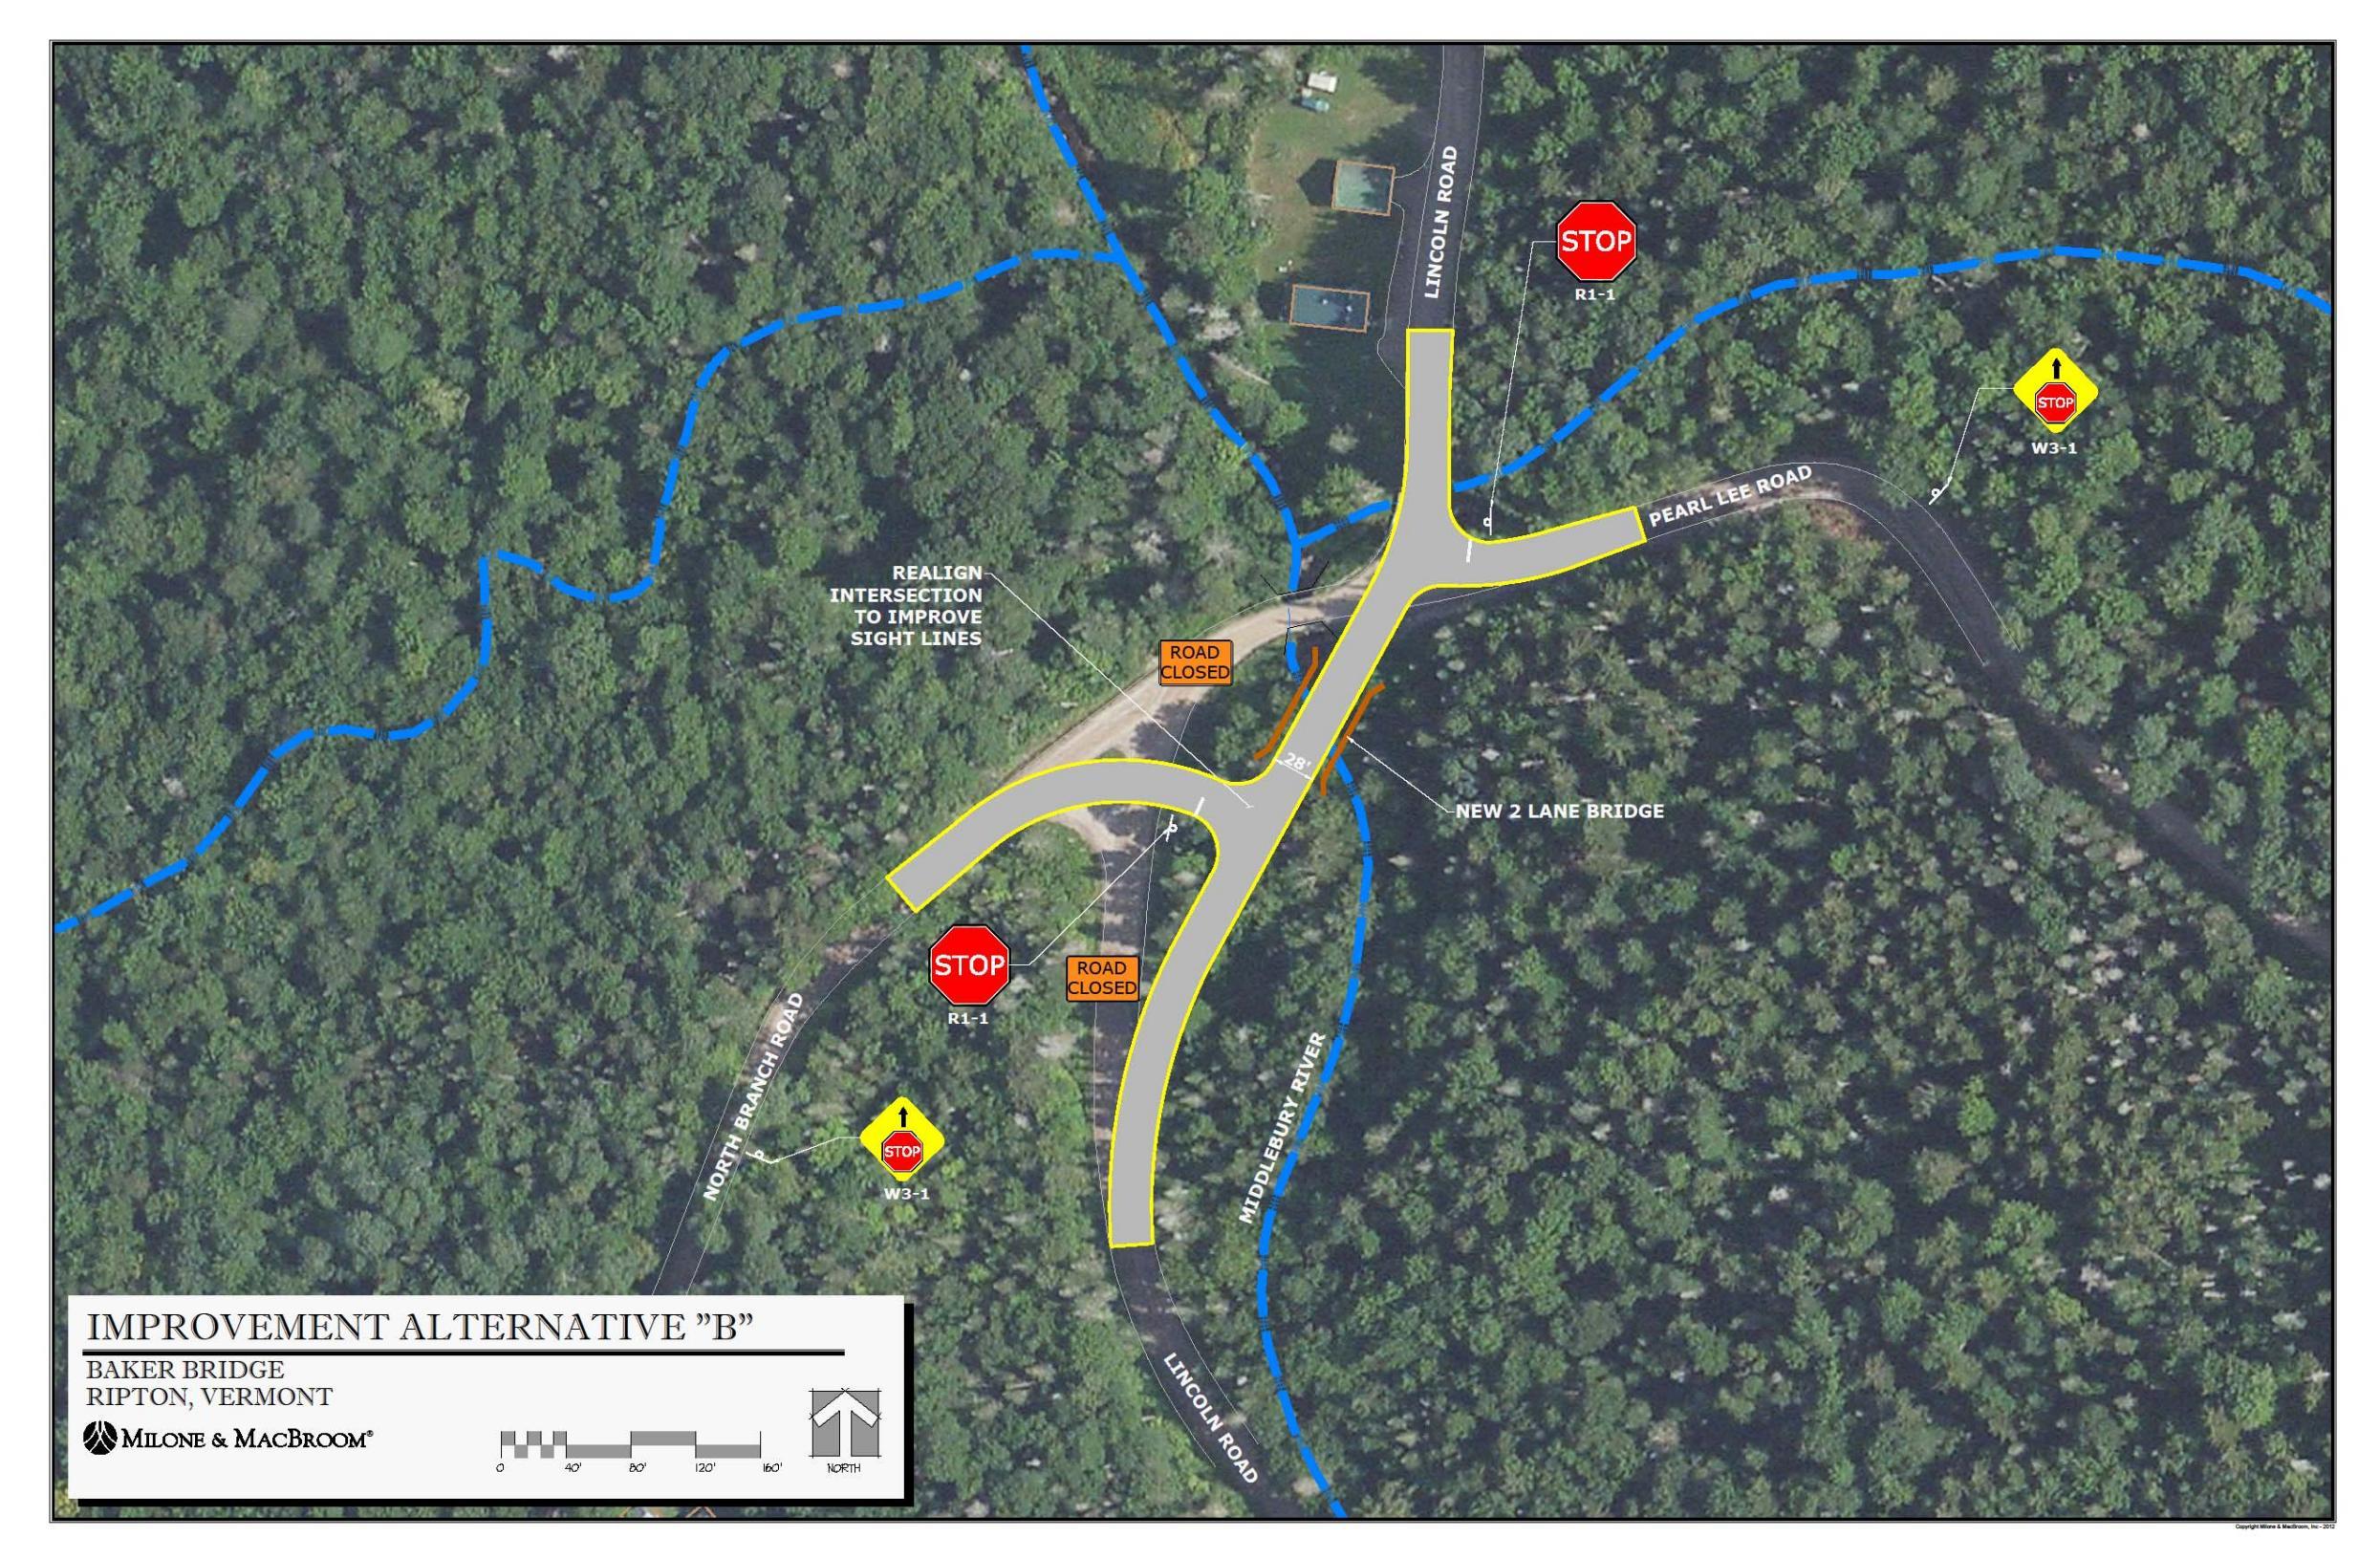
Figure 4.2 - Improvement Alternative B

*Improvement Alternative B* would involve the realignment of the offset intersection such that Lincoln Road would serve as the predominant route, which is consistent with measured traffic volumes, while North Branch Road and Pearl Lee Road would serve as side roads. This reconfiguration would improve sightlines and traffic operations. The North Branch Road and Pearl Lee Road approaches would be stop sign controlled. In addition, "Stop Ahead" signs would be installed on North Branch Road and Pearl Lee Road in advance of the offset intersection. A new two-lane bridge would be constructed on Lincoln Road, just south of the existing Baker Bridge. The roadway width across the bridge would be increased to 28 feet (12-foot lanes with two-foot shoulders). This alternative would produce the largest amount of potential impacts to natural resources. Figure 4.2 presents a schematic layout of *Improvement Alternative B*.

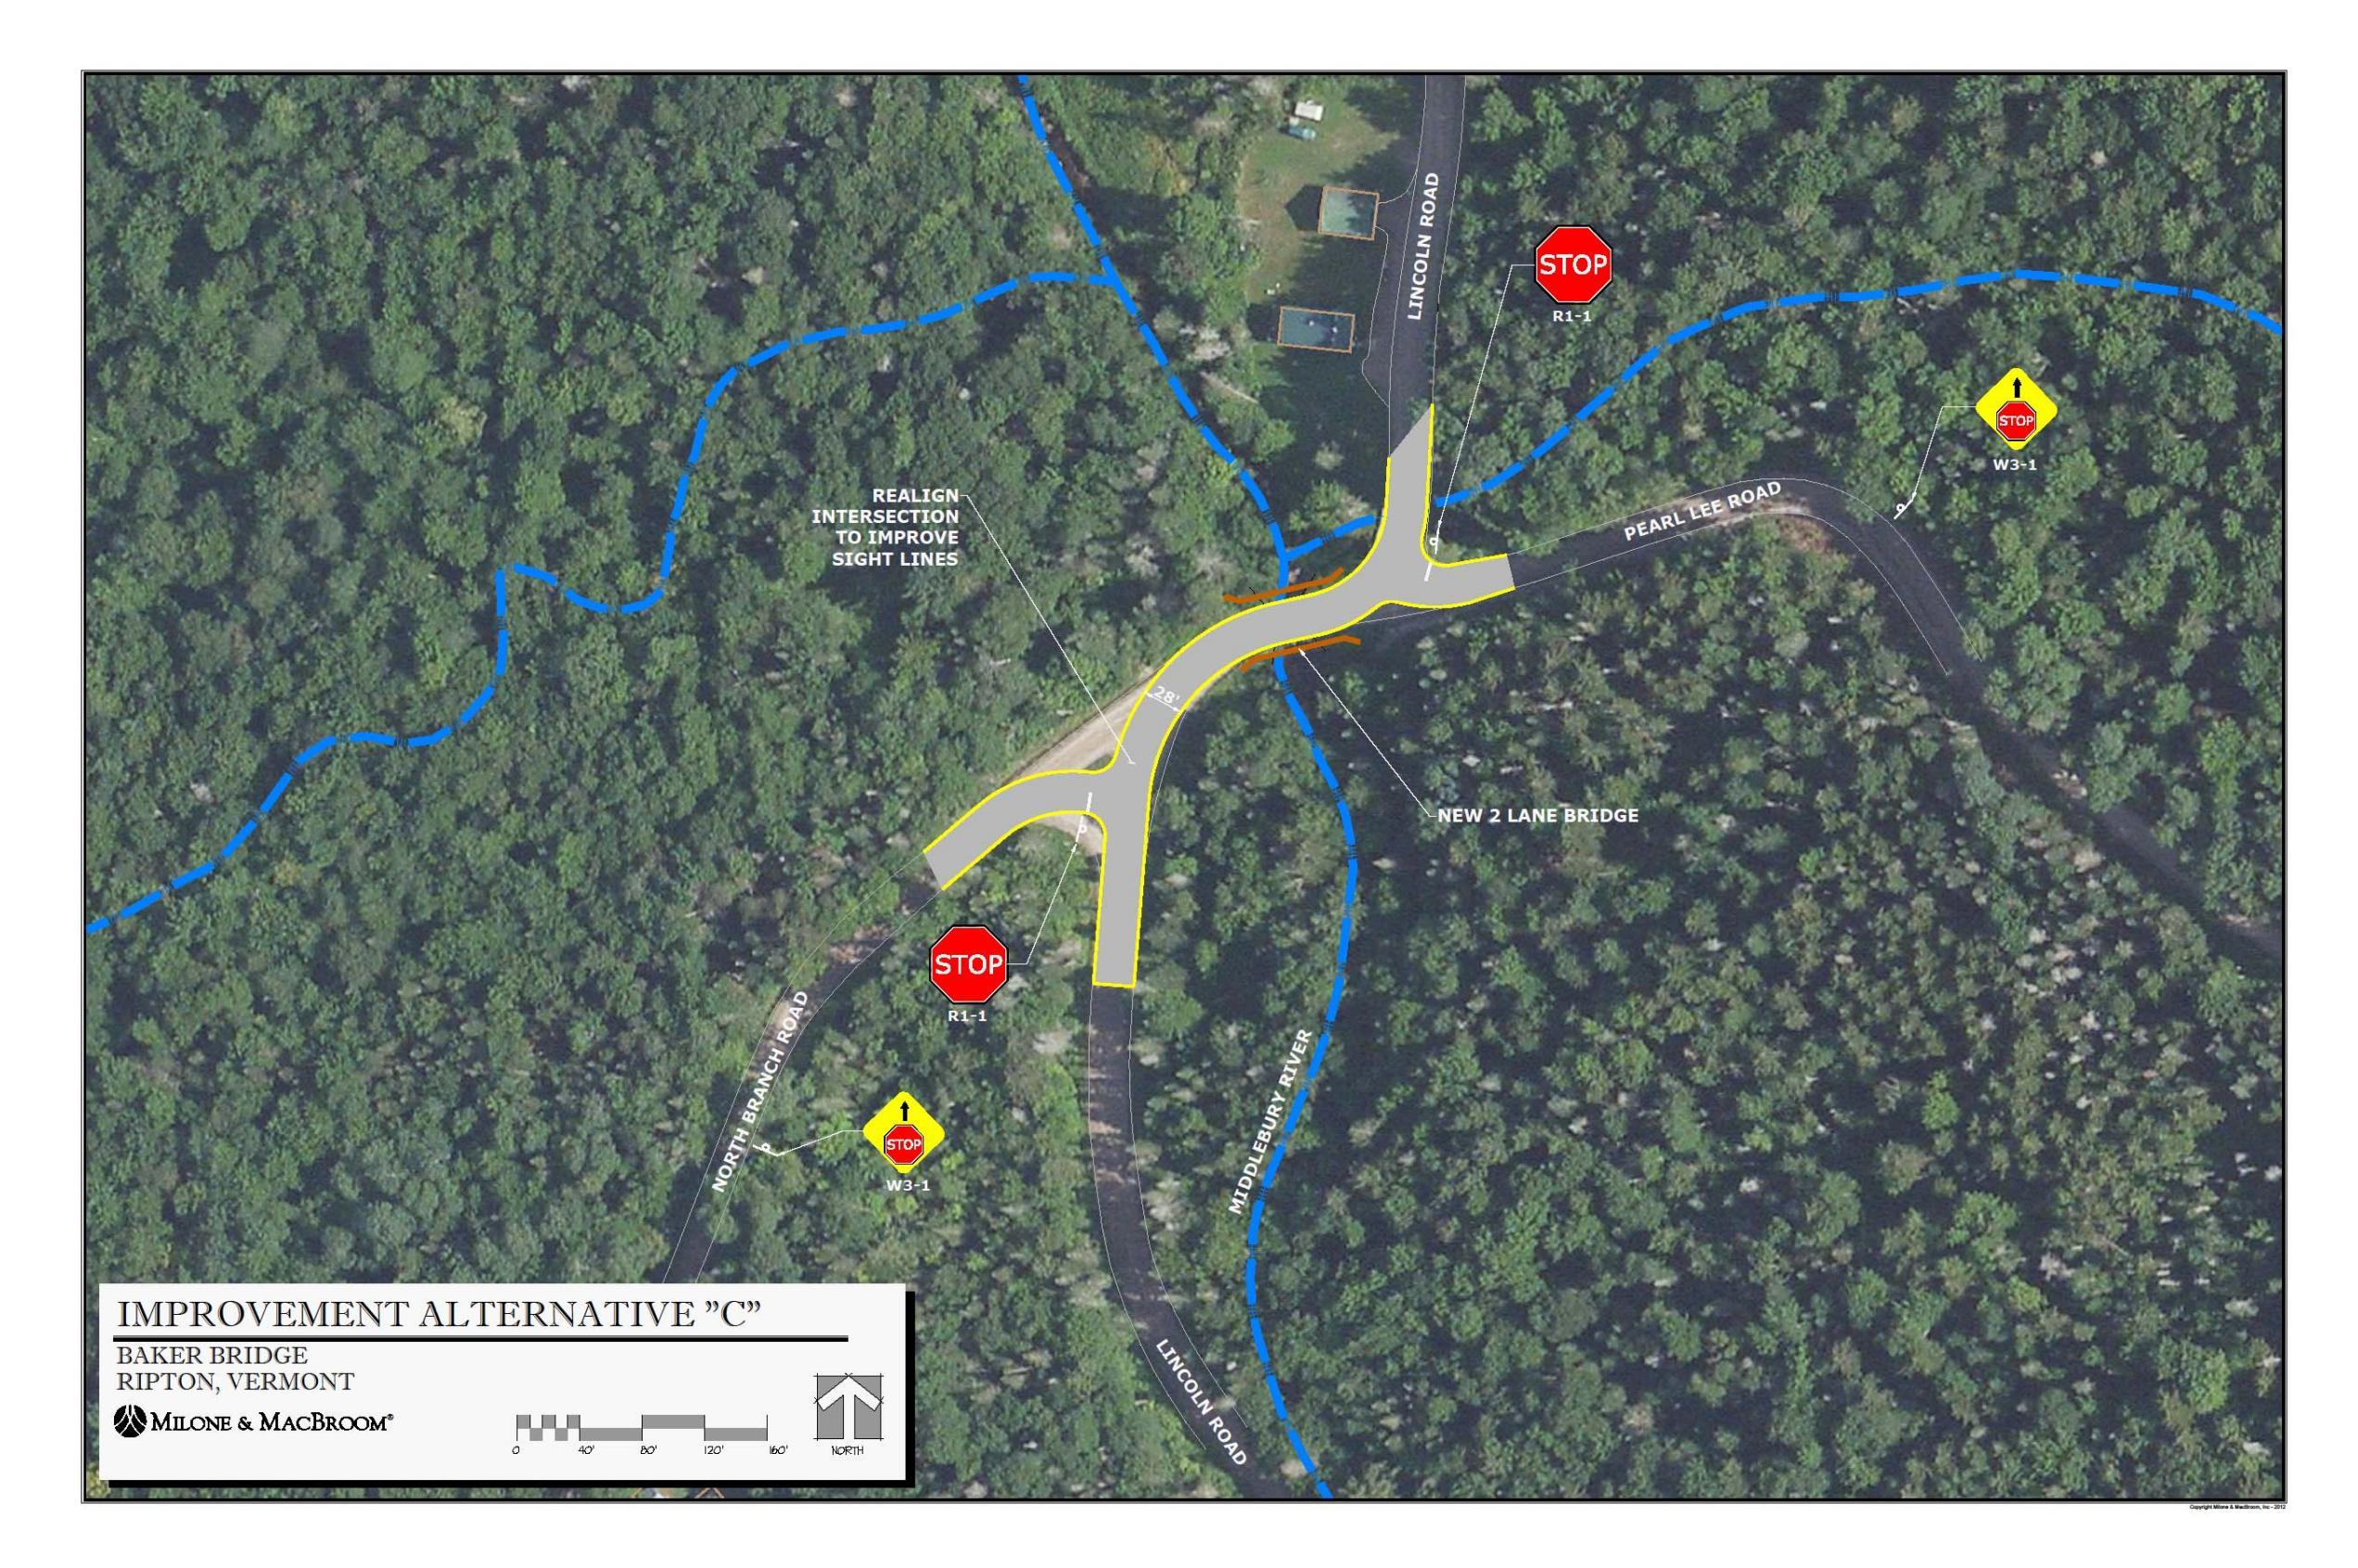
Figure 4.3 – Improvement Alternative C

*Improvement Alternative C* would be similar to Improvement Alternative B but less drastic in terms of roadway realignment. Lincoln Road would serve as the predominant route while North Branch Road and Pearl Lee Road would serve as side roads. The North Branch Road and Pearl Lee Road approaches would be stop sign controlled. In addition, "Stop Ahead" signs would be installed on North Branch Road and Pearl Lee Road in advance of the offset intersection. This realignment alternative would improve sightlines and traffic operations. Given that the majority of this alternative occurs within the existing roadway alignment, potential impacts to natural resources will be limited. Figure 4.3 presents a schematic layout of *Improvement Alternative C*.

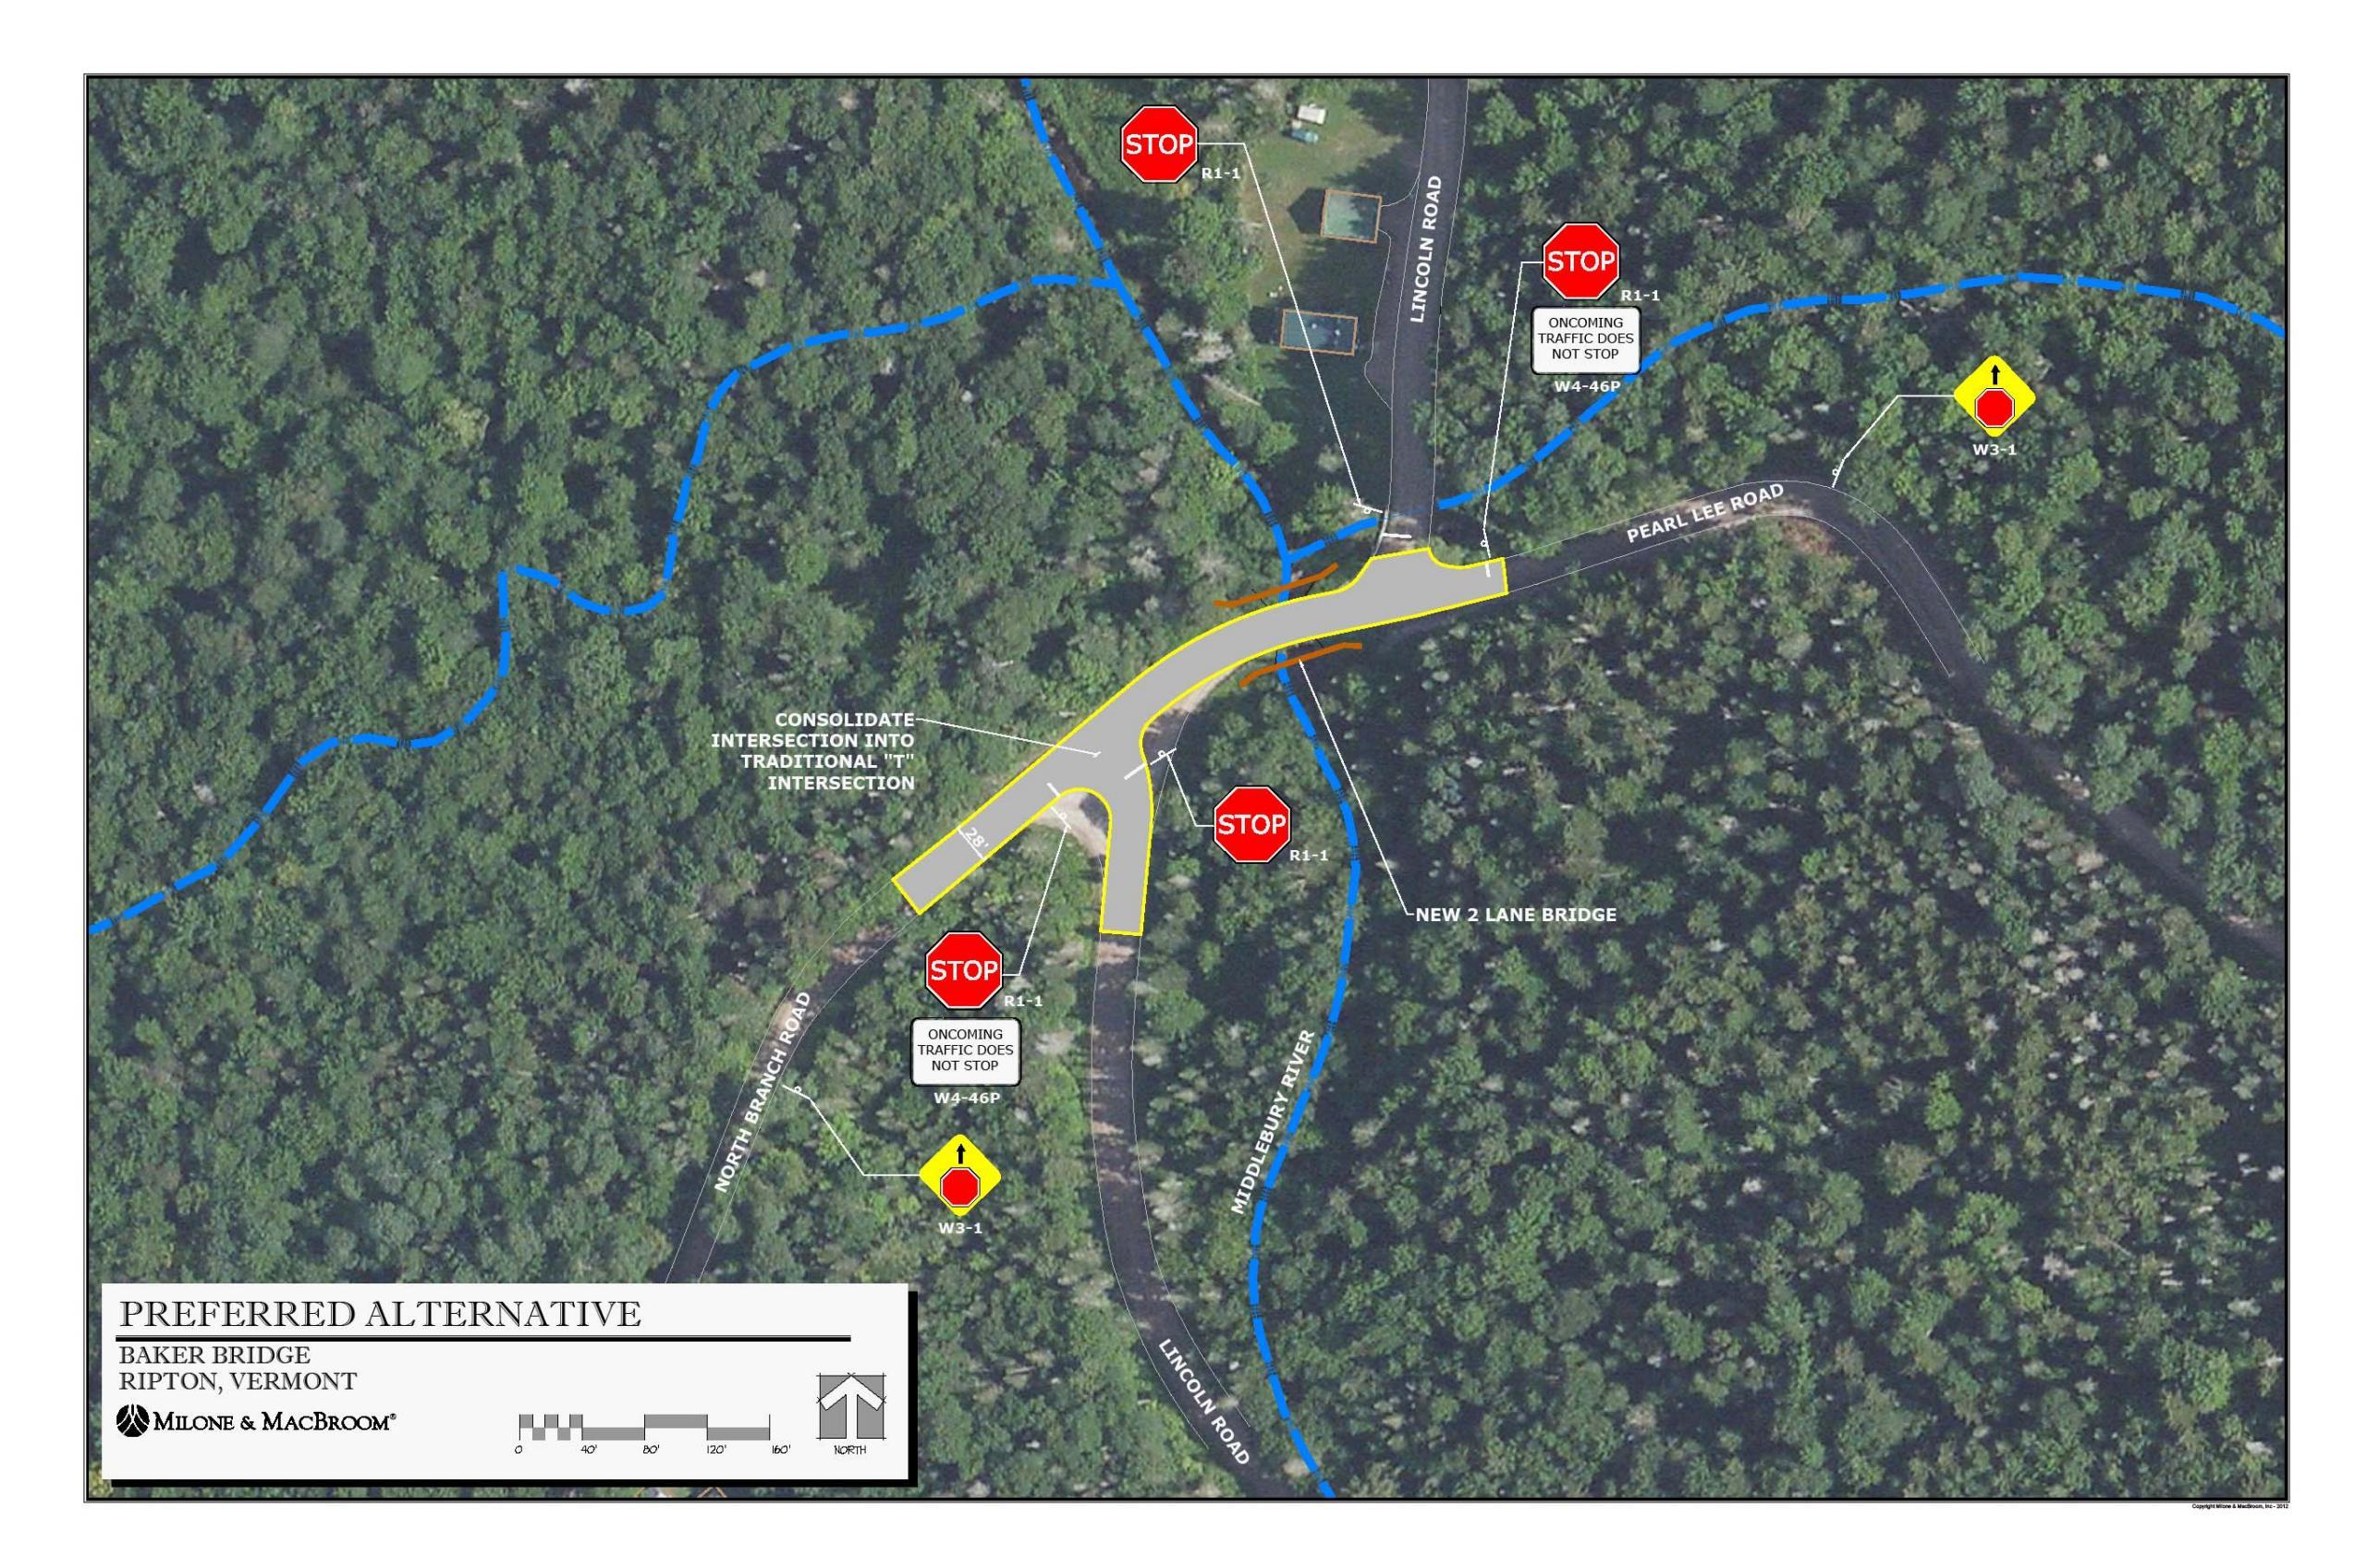
Figure 5.1 - Recommended Roadway Improvement Alternative

alternatives analysis, and cost opinions were discussed. Discussion and input from the meeting appeared to reach consensus on a modification of Alternative A as the preferred alternative (Figure 5.1).
