| STRUCTURE INSPE | CTION, INVENTORY and APPRAISAL SHEET |
| Vermont Agency of Transportation | on ~ Structures Section ~ Bridge Management and Inspection Unit |
| Inspection Report for : LINCOLN | Bridge No.: 00018 District: 5 |

Team Lead: Justin White, Inspection Date: July 27, 2021

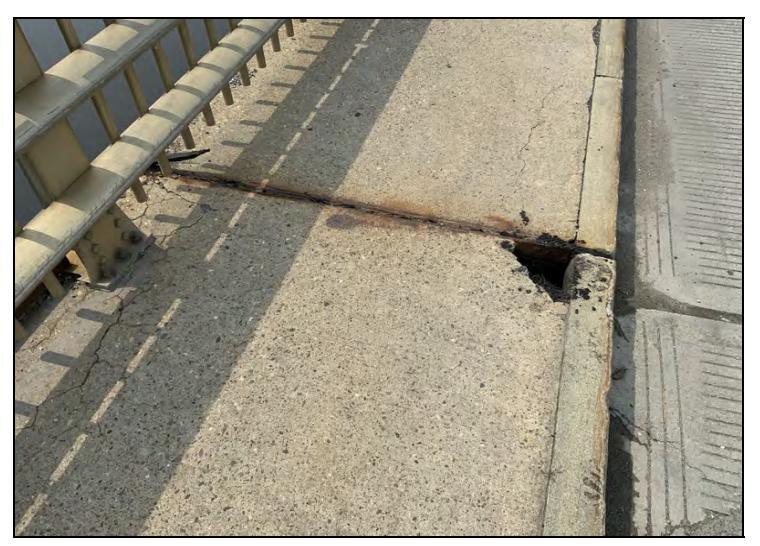
Sidewalk

Comment: Lineal cracking along the curb edge throughout with areas of minor separation and minor rust staining. Areas along the curb joint have scattered small spalls and pop outs. Areas surrounding the joint ends at the curb and fascia have delams and some small full depth holes.
