То:	Town of Lincoln, Vermont	From:	Brian Cote, PE, CFM
			Osman Pekin
			Elizabeth Richards
Company:		SLR International Corporation	
cc:	Addison County Regional Planning	Date:	September 18, 2023
	Commission	Project No.	146.13928.00008
RE: Rive	r Road Stabilization

RIVER ROAD STABILIZATION PROJECT TOWN OF LINCOLN, VERMONT

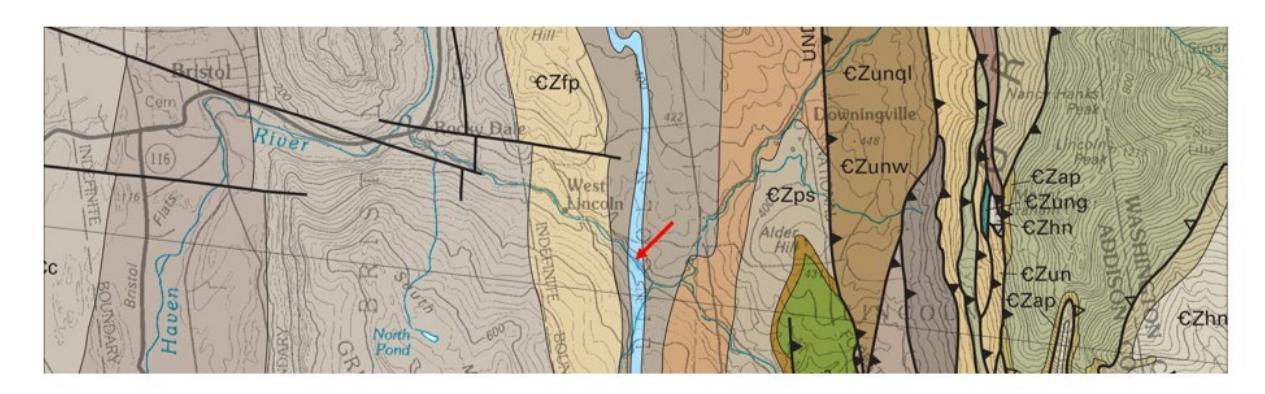
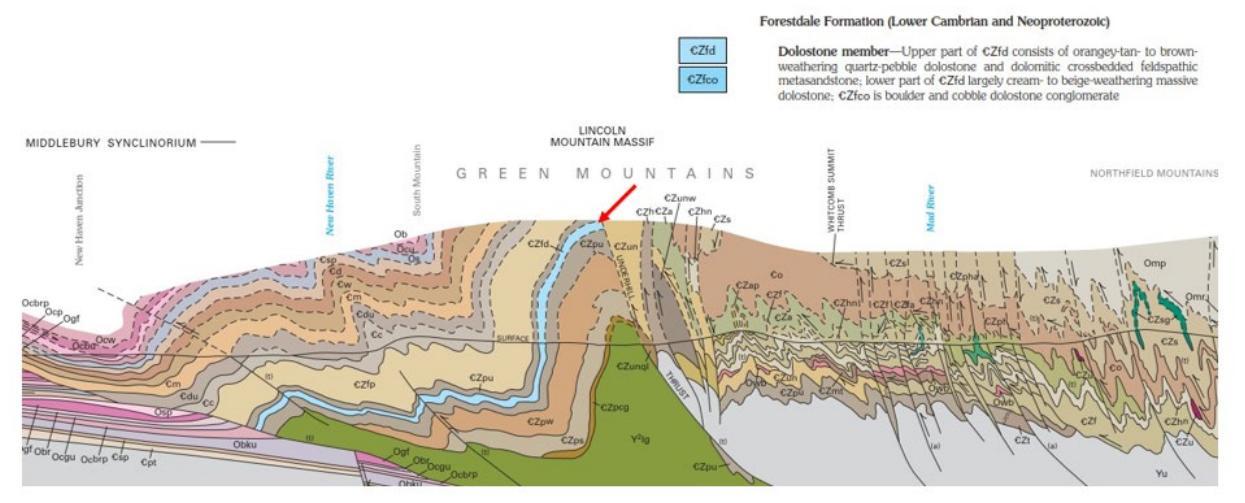
Figure B: Regional Geological Map

Data provided on regional geology map was reviewed and indicates that there is underlying hard rock at the site (USGS Bedrock Geologic Map of Vermont (Ratcliffe et al., 2011)). This site is located approximately where the Forestdale Formation (light blue band) crosses the New Haven River (Figure B).

The regional geologic maps are a good source of data, however do not provide information on local variability. For example, the upper slope along Forge Hill Road may have been created by infilling a historic flow channel, in which case the materials within a potential slide zone could consist of soil, which is more susceptible to sliding than bedrock. Also, groundwater conditions, which are currently unknown, could influence slope stability.

If hard rock is encountered within reasonably shallow depths in boring explorations, that would preclude the likelihood of deep-seated global failure. There could still be localized shallow and/or narrow weak zones, but geometrically, those would not lead to a global slope failure. The likelihood of rock being encountered during boring investigation is reasonably high given that occasional rock outcrops were observed at the site and considering the relatively steep gradient

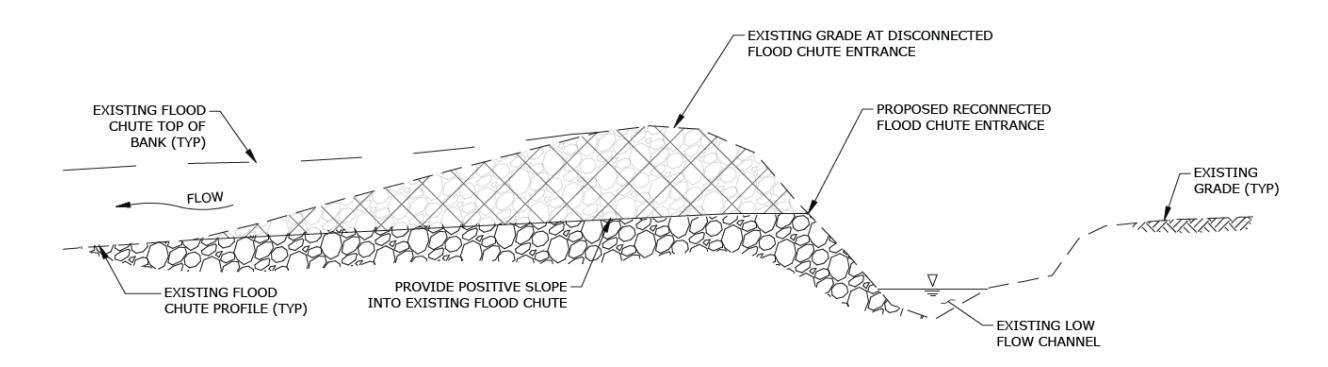
Figure M: Typical Flood Chute Reconnection Detail

A disconnected flood chute exists at the upstream end of the project site that is directing more flow towards the damaged road embankment. If reconnected, this chute could move some water away from the road during flood and reduce risk to the road.

Flood chute reconnection consists of removing material at the entrance of an existing flood chute so that it can be accessed during flood events. Currently, the flood chute that exists on the south side of the New Haven River appears to be largely disconnected from the river. During flooding, the disconnected entrance prevents floodwaters from accessing the chute. This alternative would consider lowering the existing grade at the chute entrance to allow floodwater to access the flood chute during a flood of a desired size or frequency. An evaluation of the river hydraulics during flooding would be required to determine at what flood level the chute would activate. Reconnecting the flood chute will allow a portion of the flow to enter the chute and bypass a portion of the main channel that flows along the road embankment, and therefore reduce pressure on the River Road embankment within the project site that is most susceptible to erosion. This approach has been implemented at numerous sites in Vermont in similar settings with similar constraints and conditions.

In addition, it is recommended that the Town explore flood chute reconnection (RC1) and channel bed armoring (RC2). Implementation of these alternatives would help reduce erosion pressure on the roadway embankment during flood events and reduce impacts to the river channel with maintenance requirements.
