# Lincoln Gap Road Winter Access Study

Addison Regional Planning Commission & the Town of Lincoln

February 2018 – FINAL REPORT

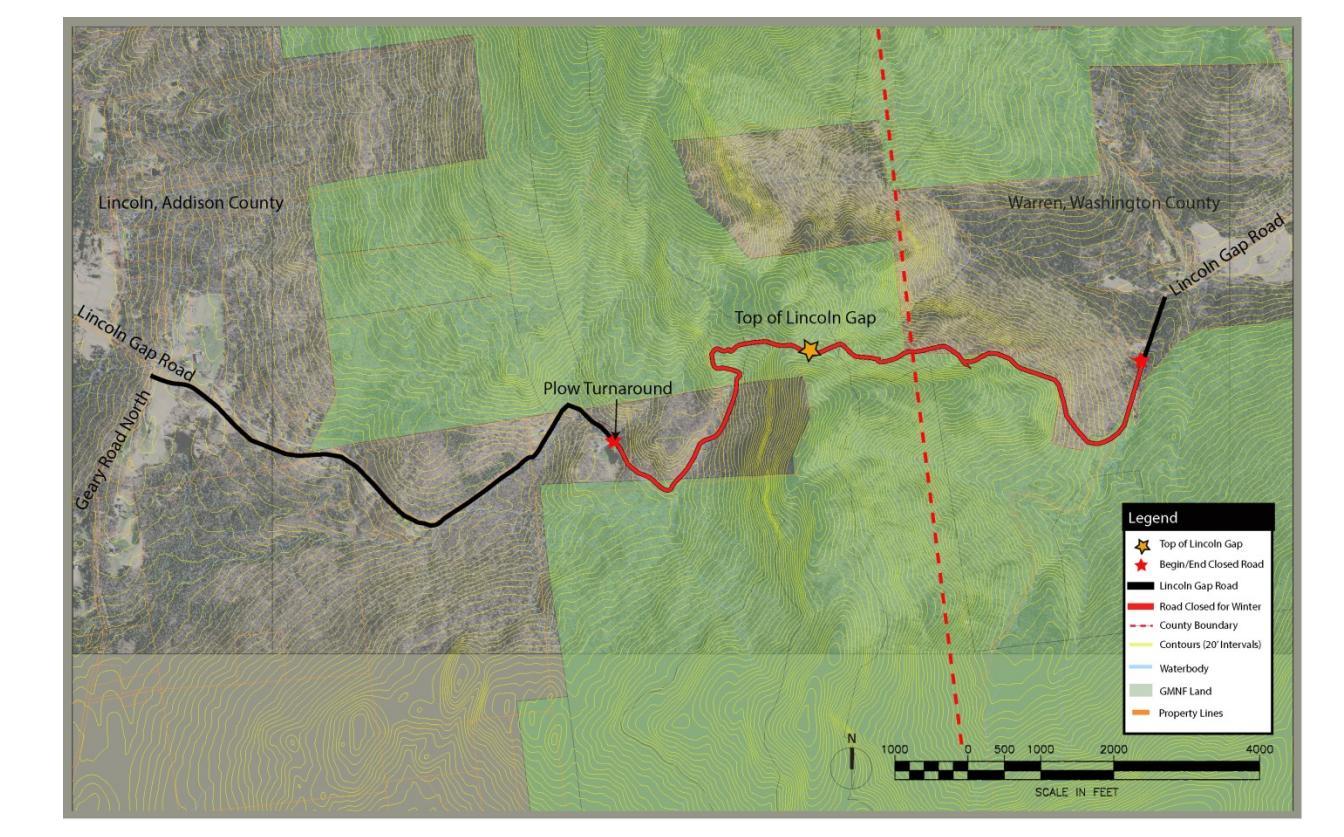
Figure 3: Lincoln Gap Road Winter Closure

Lincoln Gap Road's elevation varies between 1,820 and 2,428, with the road weaving its way up and down again. In some areas, the grade can be as steep as 24% and it is known for its challenging twists and turns. As the elevation mounts, so does the amount of forest cover over the land, which includes several blocks owned by the Forest Service; private residences become scarce as the severity of topography increases.

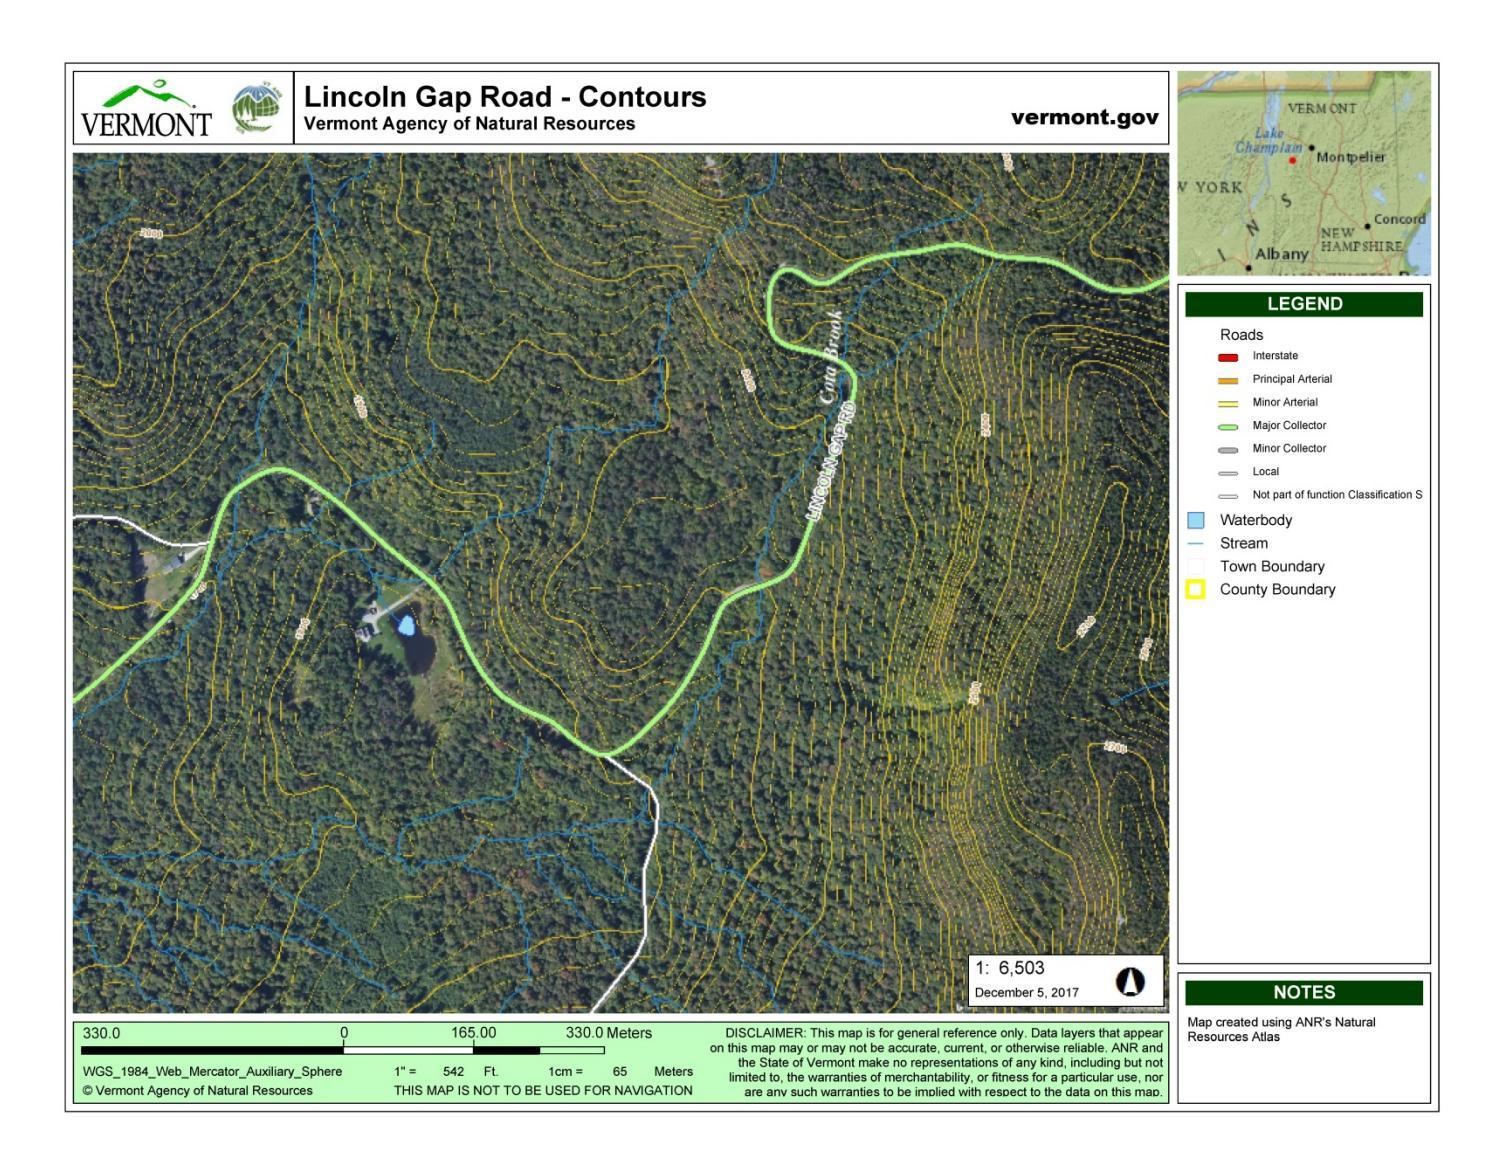
Figure 10: 20' Contours, Streams, Waterbodies in Study Area

Lincoln Gap Road has several streams crossing it and following it. It is drained on the east side by Lincoln Brook, which flows into the Mad River, the Winooski River, and ultimately, Lake Champlain. To the west, the gap is drained by Cota Brook, which drains into the New Haven River, Otter Creek, and into Lake Champlain. Below is a summary of other potential natural resources along the road and presence or absence in the study area based on available GIS information (Table 1 and Figure 10).

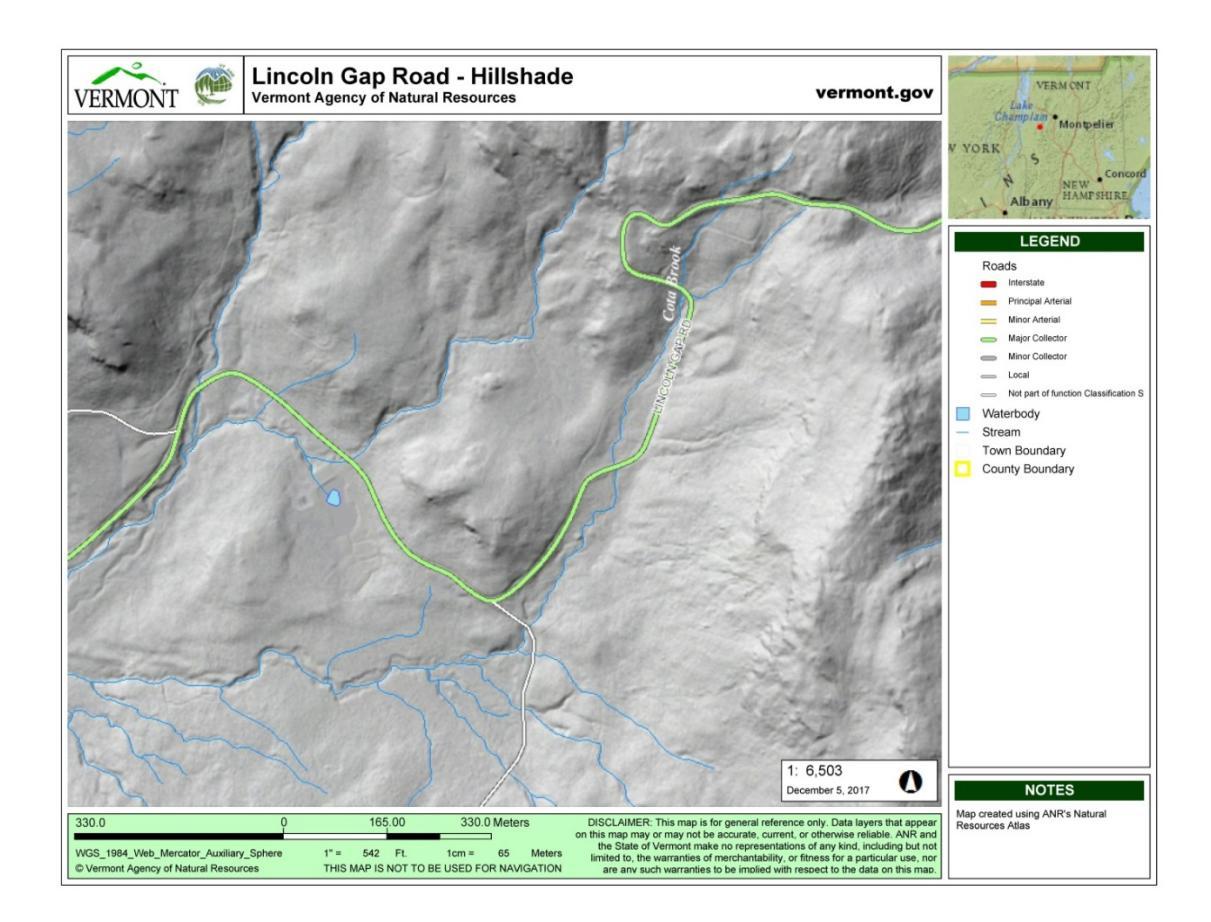
#### Figure 11: Hillshade Map of Lincoln Gap Road

A hillshade map (Figure 11) generated by LiDAR data in ANR's Atlas illustrates the land's undulations around the road and constraints for any development beyond the road's right-of-way. The last developed parcel along the road on the Lincoln side is at 2668 Lincoln Gap Road, which is

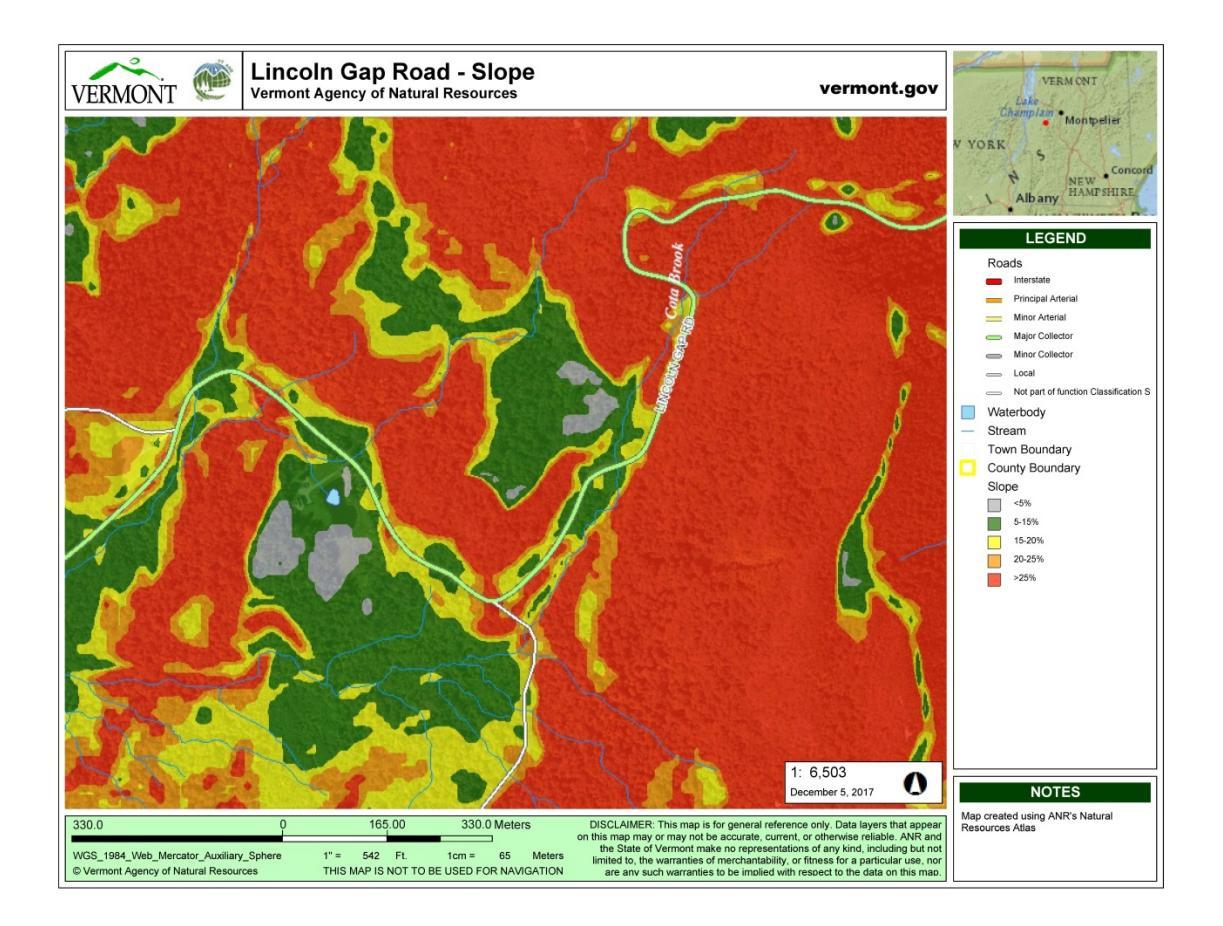
Figure 12: Slope Map of Lincoln Gap Road

on a plateau/ flat area. The slope map (Figure 12), also illustrates the intensity of the slope along this portion of the road. Per the slope map, the current plow turnaround is in an area of gentle slope, varying between 5-15%, with intense slopes of 25% or greater as the road progresses east towards Warren. The first bend after the current road closure area is especially intense, with an approximate 22% incline (based on GIS data of 20 foot interval contours).

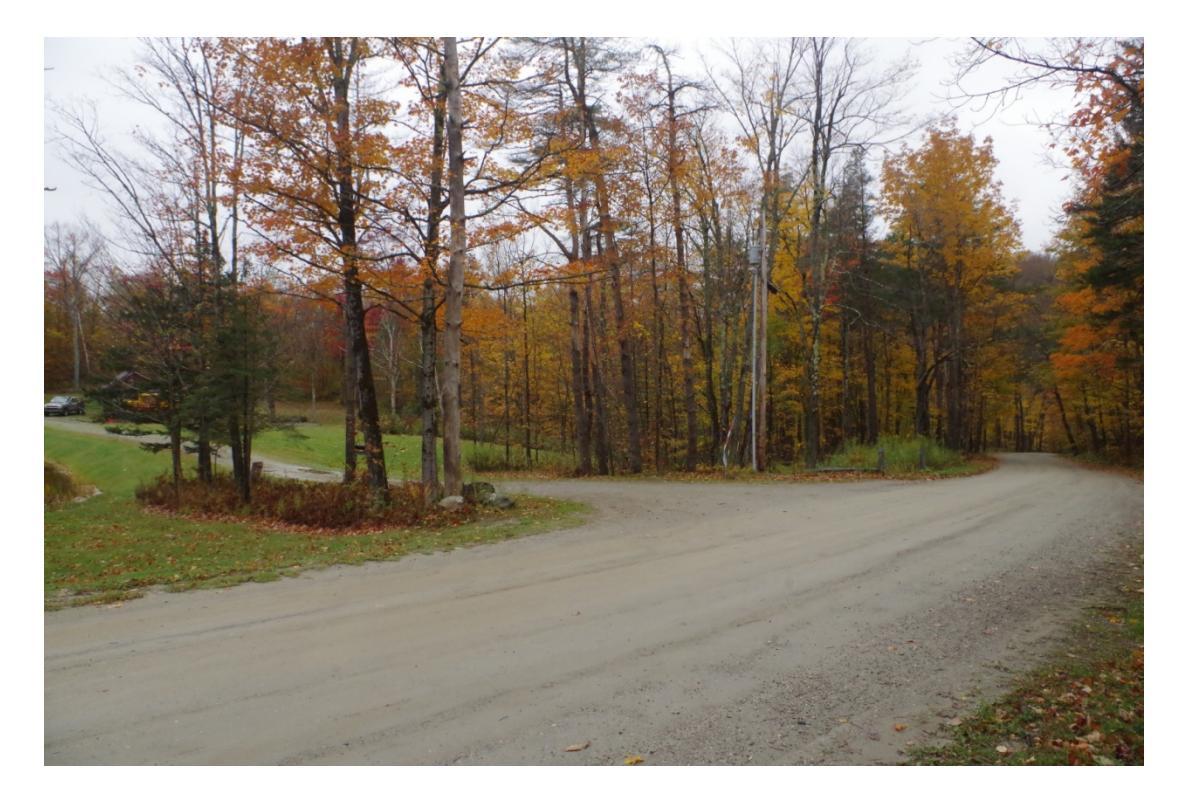
Figure 13: Existing Plow Turnaround Area on Lincoln Gap Road

A road profile generated with existing Vermont Center for Geographic Information (VCGI) data illustrates that the current plow turnaround area has an approximate grade of 6.4% (Figure 13 & 14).

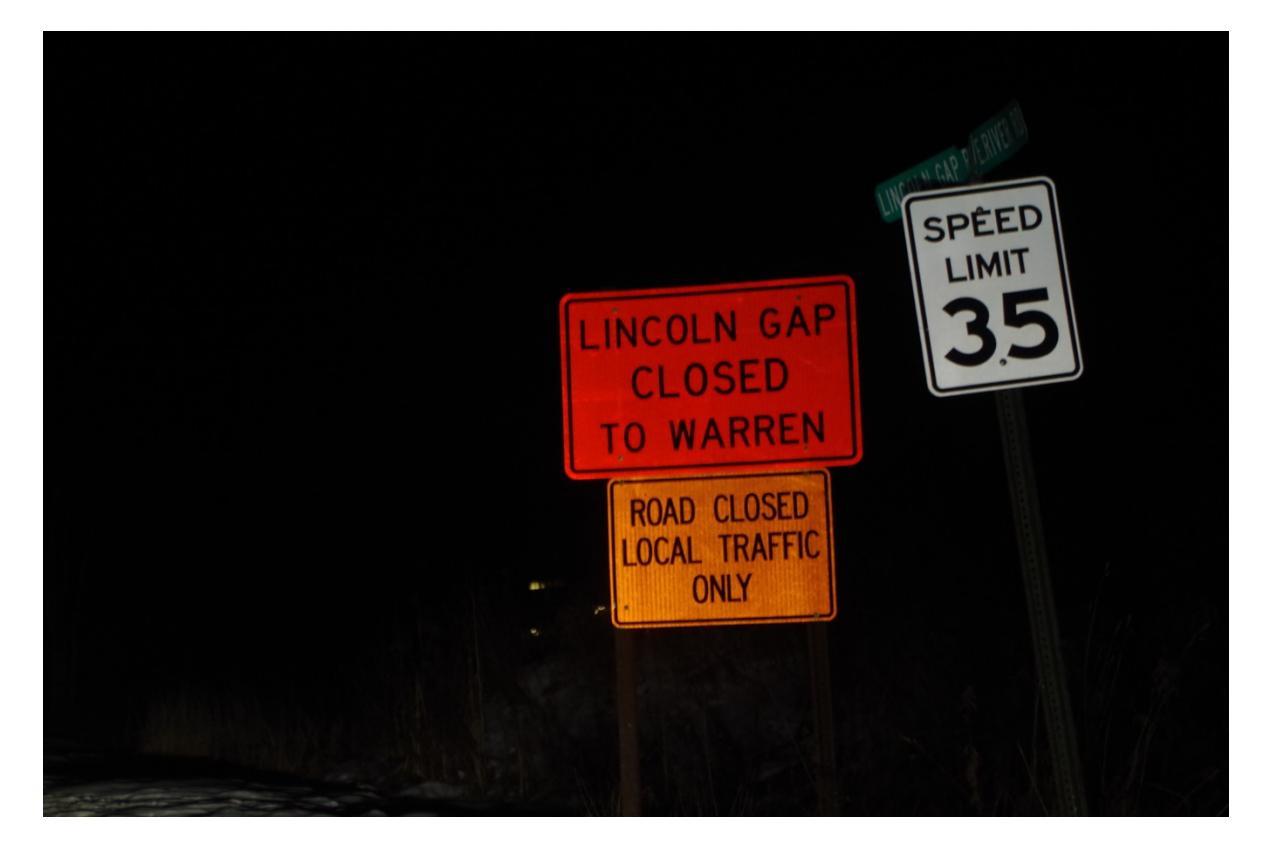
Figure 15: Road Closed Signs on Lincoln Side at East River Road/South Lincoln Road/Lincoln Gap Road Intersection

Along Lincoln Gap Road from the Town of Lincoln side, there are 4 posted signs indicating that the road is closed during winter. These signs are installed by the Town on or around October 15<sup>th</sup> and removed and stored in May each year. The signs are posted progressively up the mountain, until reaching the area where the plow currently turns around (Figures 15, 16 & 17). At the time of the study, the Town of Lincoln's plow clears the road up to the last home on its side of the gap, at 2668 Lincoln Gap Road, which is a seasonal cabin. This is approximately half a mile beyond the next closest residence.

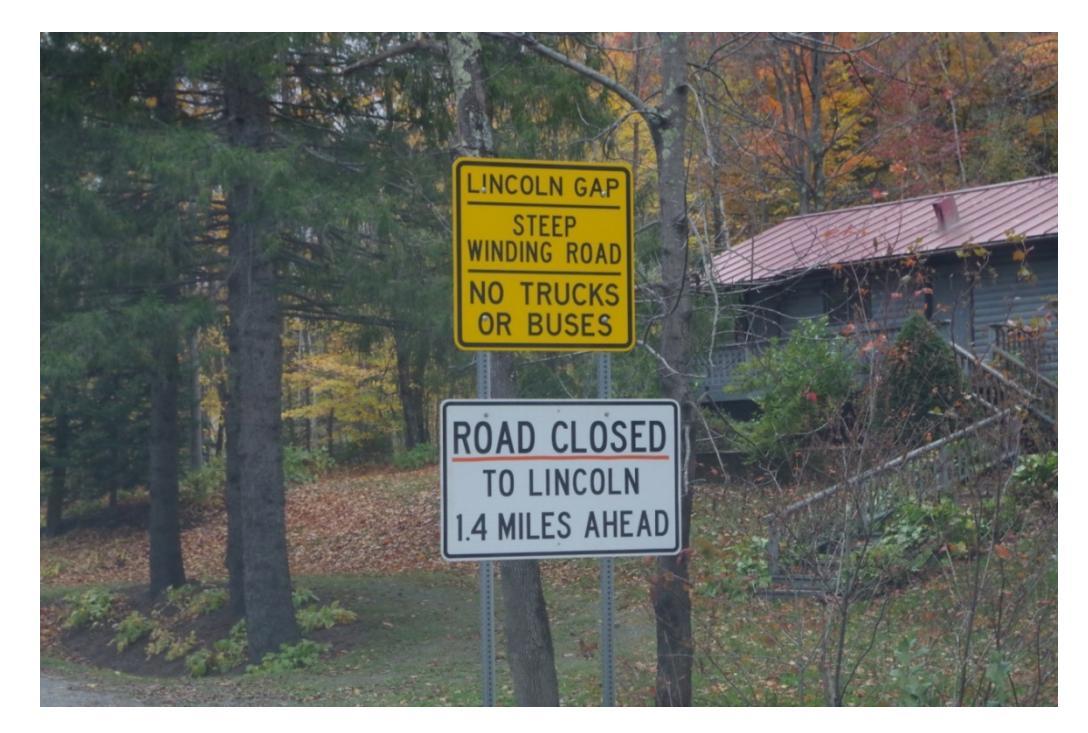
Figure 18: Road Closure Signs: Warren at bottom of Gap

Signage is also posted within the same timeframe from the Warren side of Lincoln Gap Road. In addition, Warren posts that there is a gate ahead to further deter motorists from continuing up the closed road, or from the Lincoln side, from venturing down the gap if they've ignored signage on the Lincoln side and are headed down towards Warren (Figures 18, 19 & 20).

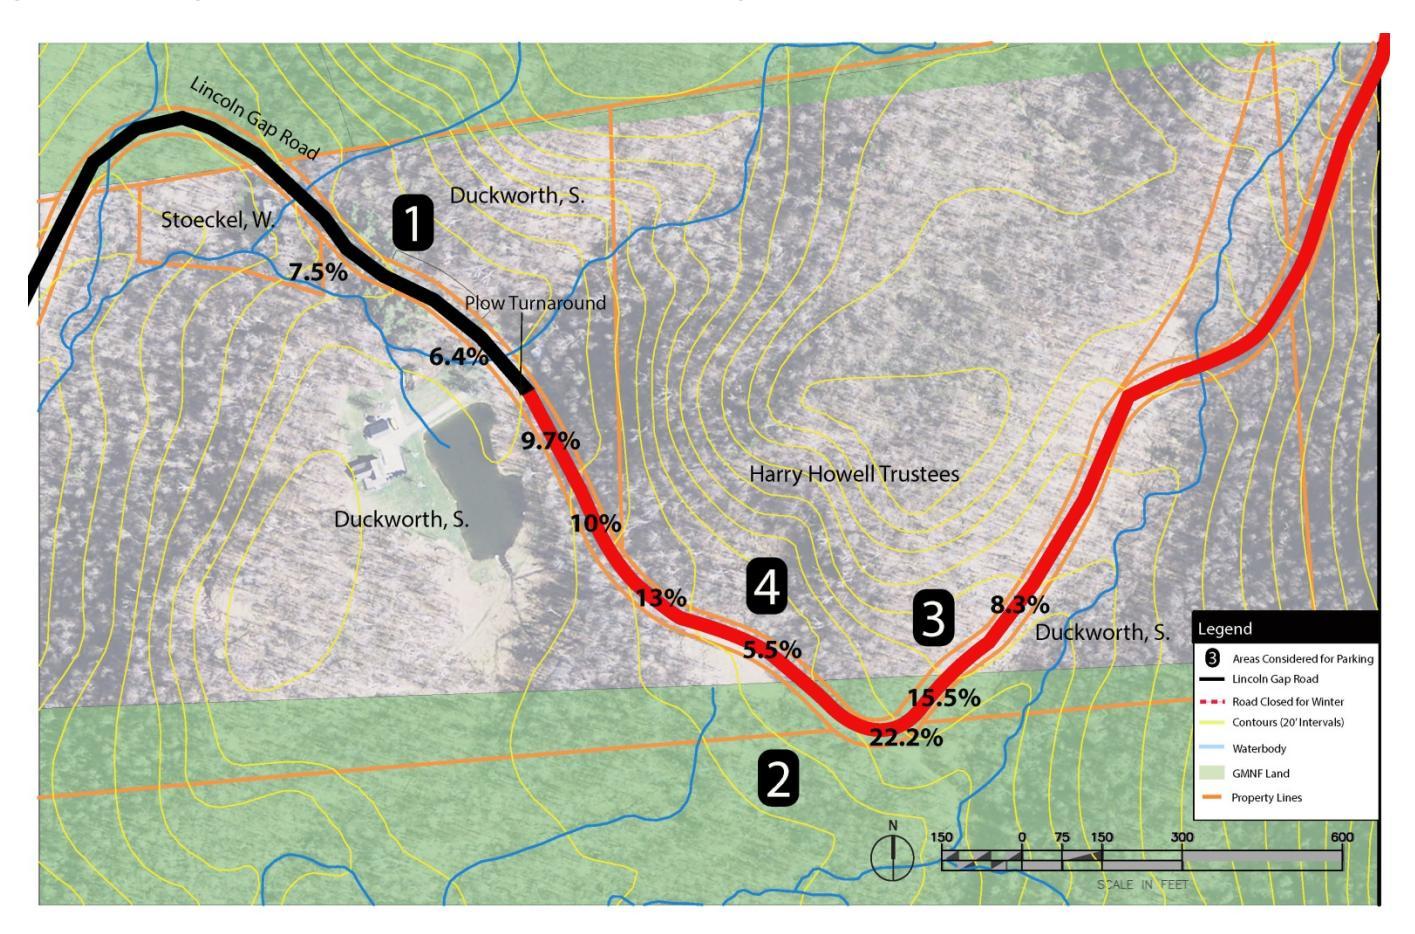
Figure 21: Parking Alternatives — Land Ownership and Existing Grades

Considering the location, there are few relatively flat areas near the current snowplow turnaround that can provide a suitable parking area. In addition to geographic constraints, the flatter areas are located on private and public property, or are near natural resources such as streams. Figures 21 and 22 illustrate both in plan and section the current grades and landownership along Lincoln Gap Road in the vicinity of the current snowplow turnaround.

Current landownership is included in Figures 20 and 21. Option 1, which is before the current snowplow turnaround and adjacent to road, would require an easement beyond the right-of-way limits. Option 2 is on GMNF land, and would require an easement from an adjacent landowner. Options 3 and 4 are on land that could potentially be purchased, and the current owner has expressed willingness to negotiate parking and a snowplow turnaround on their land.

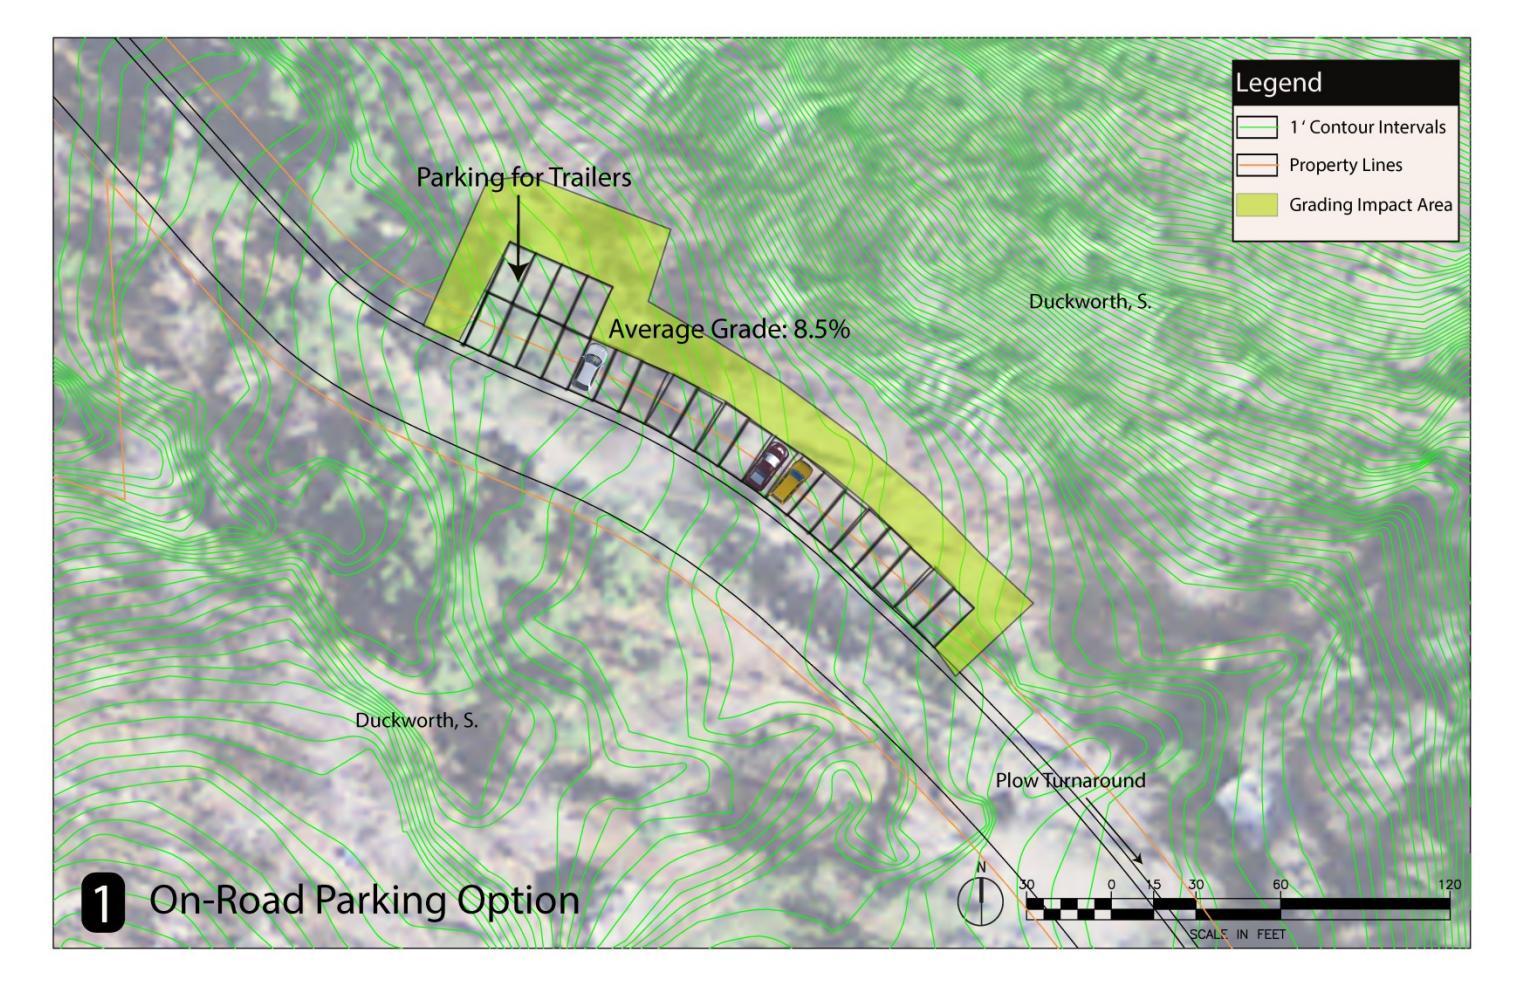
#### Figure 24: Option 1: On-Road Plan

the road, parking for 20 vehicles, including 4 of these to accommodate trailers, and reconnecting to the existing topography at a 2:1 (50%) slope. As the area is adjacent to the road, the parking would widen the existing break of the high priority habitat blocks but would not create a new 'break'. Figure 24 illustrates in plan the 20 proposed parking spaces (including 4 longer spaces to accommodate snowmobile trailers) along the existing road. Figure 25 illustrates in section the existing grades and the potential area of 'cut' that would be required to create a parking area at this location. A substantial amount of vegetation would need to be removed to create the parking area. Per soil maps, the area could be rocky and may require challenging excavation to accommodate a parking lot.

Based on the design criteria, project goals and objectives and analysis of the four sites for a parking area along Lincoln Gap Road, Option 1 is recommended for further development. The final selection is dependent on discussions with the landowner of the Duckworth property, as well as the evaluation of other components including: maintenance requirements of any surface parking area, snow storage strategies, and signage directing users to the parking areas and away from the areas that are currently creating challenges for the snowplow.

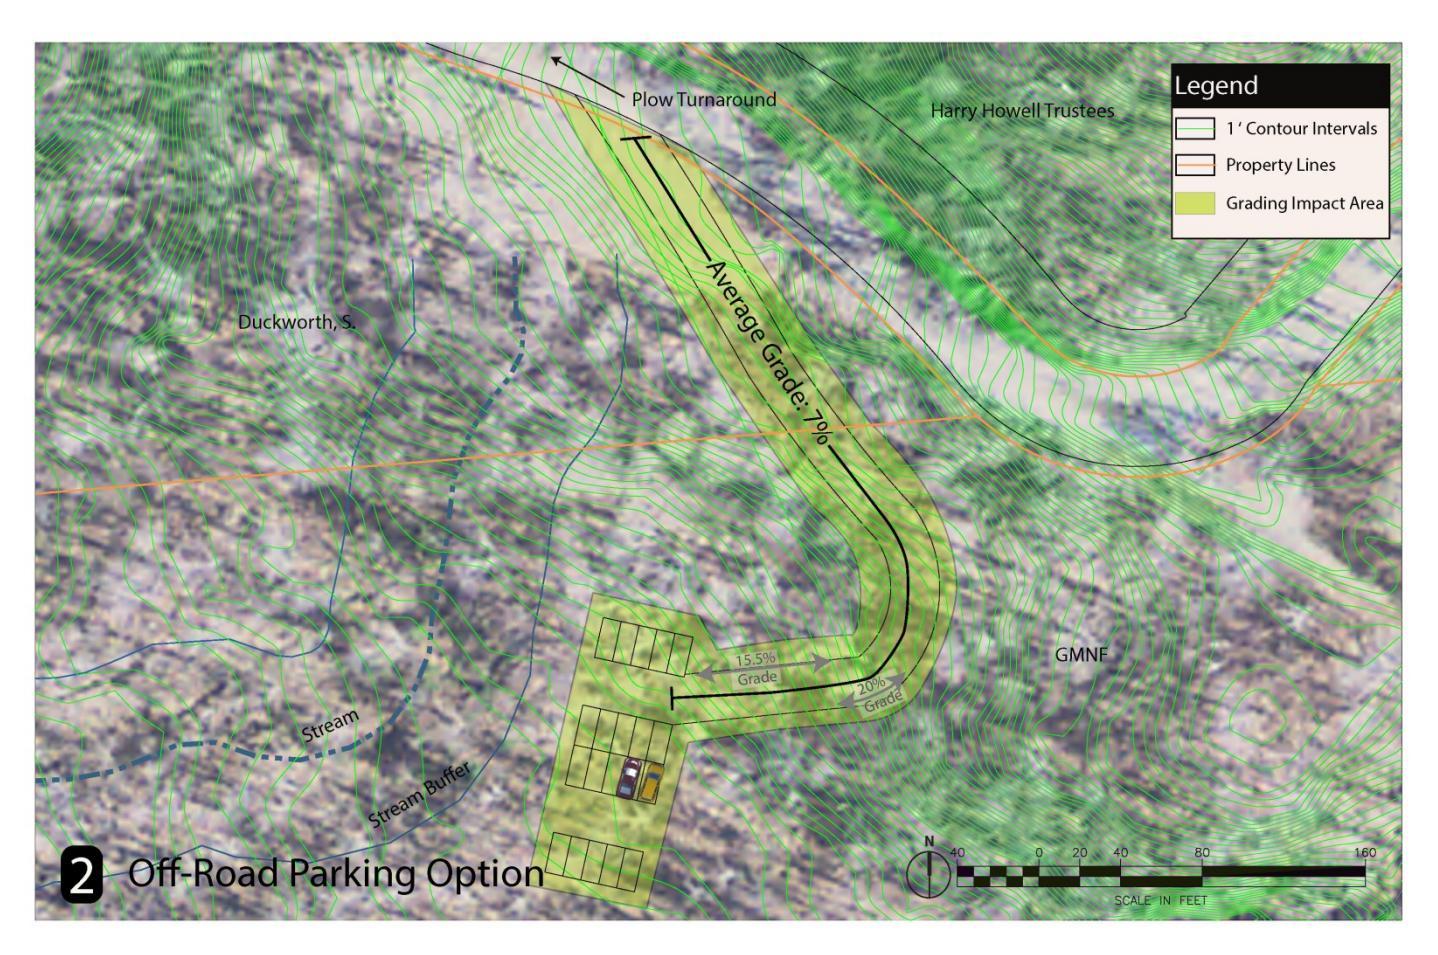
Figure 26: Option 2: Off-Road Plan

Option 2 would be at least 80 feet up the road from the current plow turnaround and require a minimum of a 410 foot access road to reach a reasonably gradable area on forest service land. Benefits to locating the parking area away from the road include: safety, an ability to close it off during non-winter months, and the potential for expansion. However, this option would require the removal of a significant amount of vegetation, regrading a large area and a break into the habitat block surrounding the road. The access road would cross private land, requiring an easement. Changes to GMNF land may trigger a NEPA evaluation. Where it is possible to follow the contours for part of a proposed road, the average grade is 7% between Lincoln Gap Road and the proposed parking lot, with steep sections with grades of up to 22%. The steep grades on the road will be difficult to maintain and plow. Parking in this area is also limited by streams and their buffers, limiting the option of future expansion and increasing potential environmental impact.

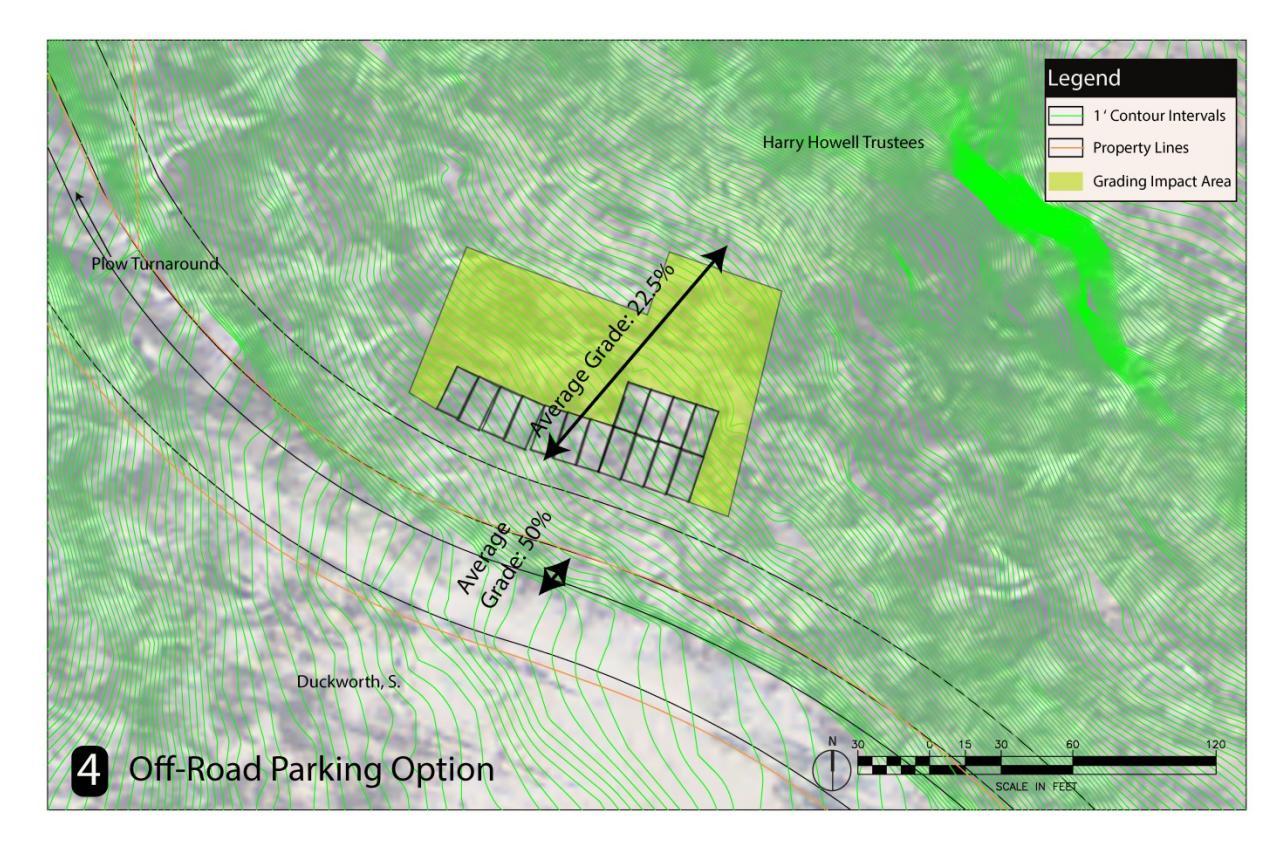
Figure 27: Option 4 - Near Road Plan

Option 4 envisions building a parking area near or off of the road on the north side of Lincoln Gap Road, and would also be at least 80 feet up the road from the current plow turnaround. The existing slopes are prohibitively steep. It would require significant cutting into the hillside to create a reasonable grade for access and more cutting for a parking area and plow turnaround (Figure 27 illustrates a potential parking area in order to illustrate these challenges, with only half the desired number of parking spaces and no spaces for trailers). Figure 28 illustrates a section from the right-of-way of Lincoln Gap Road, and the space required to provide perpendicular parking similar to site 1. Construction of a parking area in this location would require significant clearing, result in erosion due to the steep slopes, and would create a new break in the intact habitat blocks. Due to the above considerations of topography and environmental impacts, option 4 is not feasible.

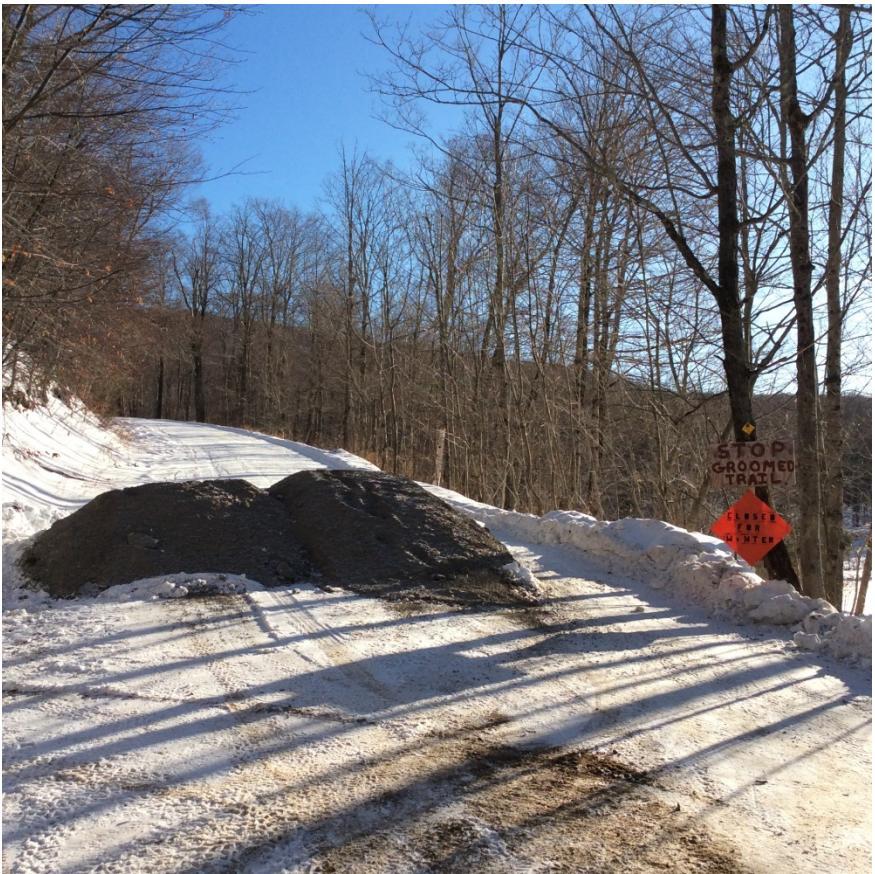
Figure 29: Gravel Piles at beginning portion of closed Lincoln Gap Road in Lincoln, Winter 2018 (Photo courtesy of Josh Donabedian, ACRPC)

At the time of the completion of this study (mid-December 2017), the Town of Warren had experienced four calls this season for rescues on the closed portion of Lincoln Gap Road. The Town of Warren was considering placing tree trunks across the road that is closed to restrict access to snowmobiles and rescuers. Warren had requested that Lincoln block the road at the top of the gap. Since part of Lincoln Gap on the Lincoln side is on the VAST trail network, any consideration of barrier should allow access to snow machines and skiers. On December 5, 2017, the Town of Lincoln voted to purchase two Jersey Barriers on the Lincoln side of the gap where the snowplow currently turns around. Further discussion ensued at the December 19, 2017 Selectboard meeting where the latter motion was amended to be the purchase of bags of gravel to be utilized to prevent motorists from venturing up the Gap (Figure 29).
